Using Vibration Analysis to Identify & Correct an Induced Draft Fan's Foundation Problem of a Pollution Control Device - A Case Study

Abstract

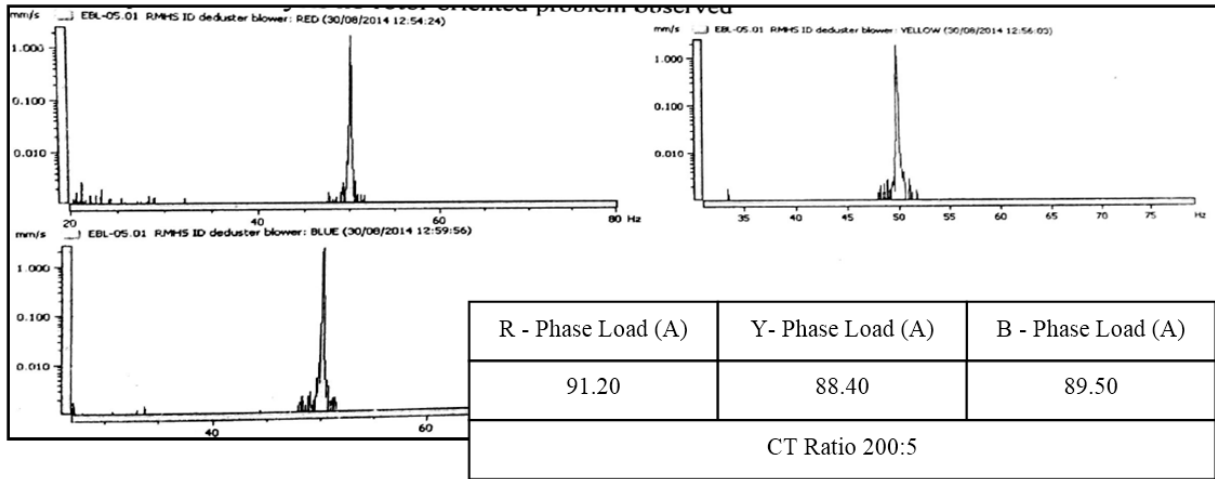
Figure 3. Current Signature Analysis Report and the Load in the RYB Phases.

From Figure 3 it is observed that there is no phase unbalance in the 3 phases and from the spectrum analysis we find there is no rotor initiated problem. With the current signature analysis it was confirmed that though the motor vibration is high but there is no broken rotor bar related issue of the motor.

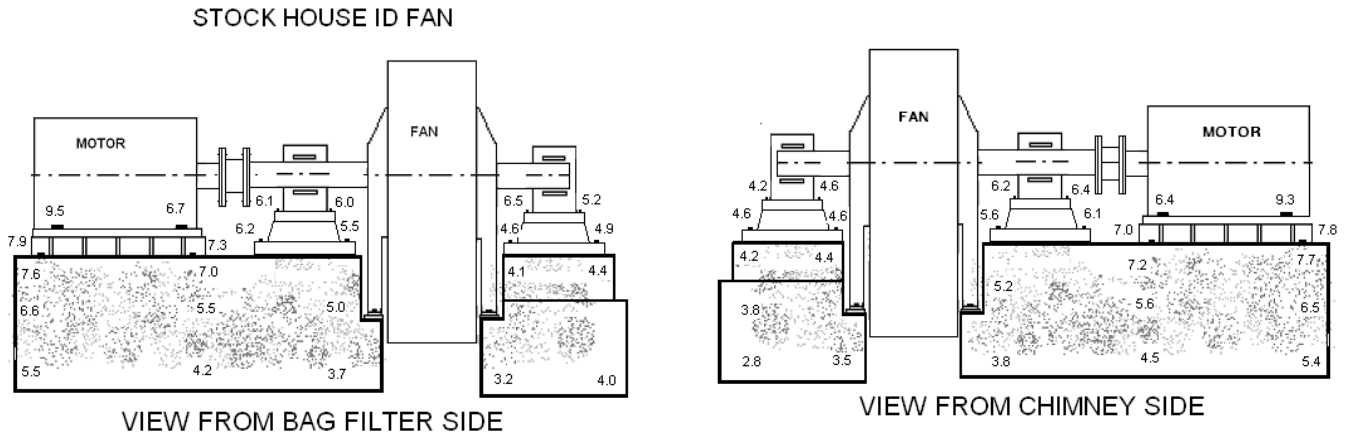
Figure 5. Vibration level mapping of the equipment and the base(view from both side).Dimension mm/sec

It is evident from the above vibration mapping that the higher vibration was at the motor side and the same was being transmitted to the base.

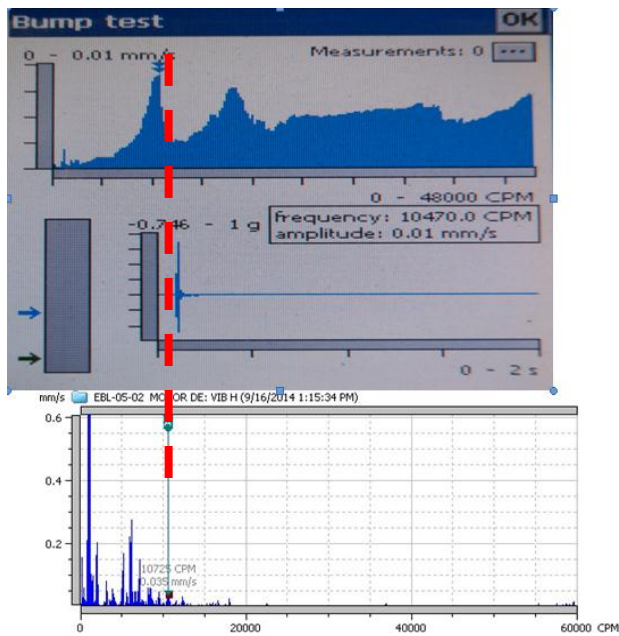
Figure 6. The result of the bump test.

From the above result of bump test it is evident that the blade pass frequency(the impeller has 12 numbers of blades) and the natural frequency of the concrete base is coinciding which is causing resonance.

Normally to avoid the resonance the usual practice is to either reduce the fan speed or to increase the stiffness of the base further. In this case study it was not possible to reduce the motor speed as it was a fixed speed induction motor and due to site restriction to increase the base size was not possible.

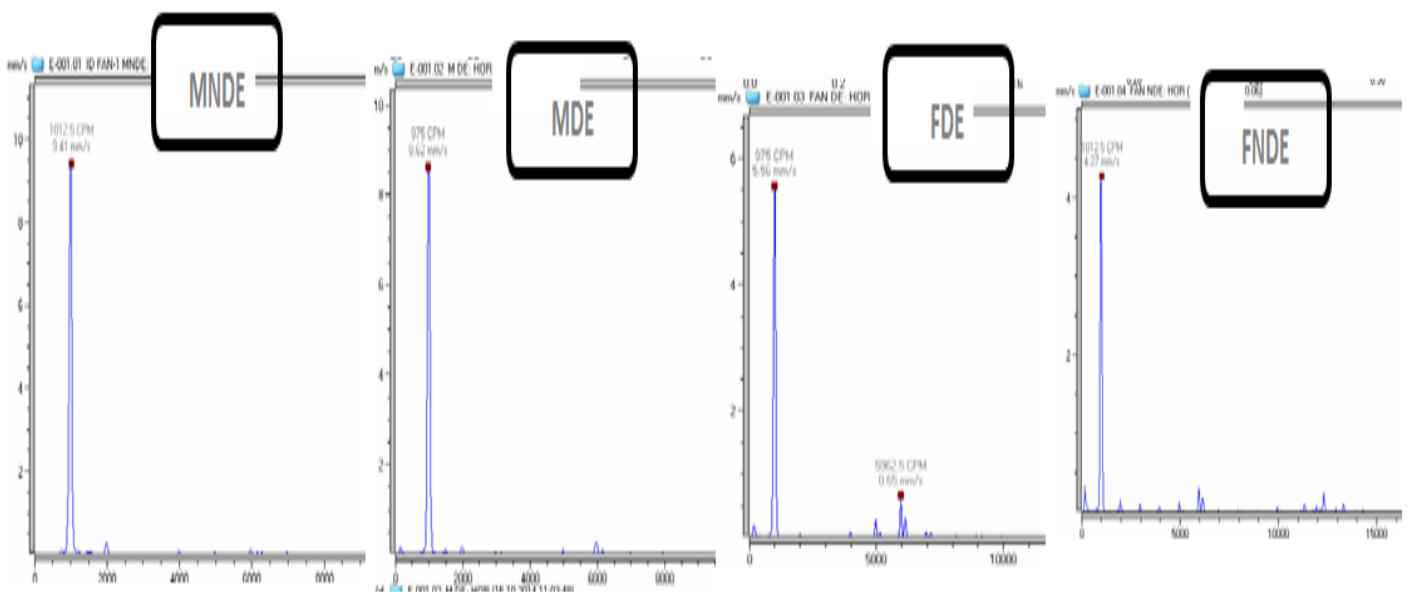
Figure 8. Vibration Signature Analysis of the Motor & the Fan Bearings in Horizontal axis

In the vibration signature analysis it was observed that the highest amplitude was at 1* running speed(X).

Troy D Feese & Phillip E Grazier [5] had observed that generally when machinery experiences high vibration at 1 x running speed the first cause can be of unbalance of the impeller and the same to be checked first. As the signature analysis indicates there is some unbalance in the impeller it was decided to check the same first and to correct the unbalance as there will be some addition of weights which may off-set the resonance forces.

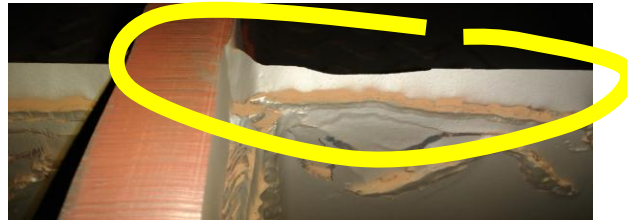
The reason of fast wearing out was due to abrasion of sand materials which were leaking from the partially damaged filter bags of the pollution control device. In the pollution control device there are 12 chambers and each chamber has 192 bags and to locate and replace the damaged from the total 2304 total bags is a time consuming task which needs a long shut down which the operation cannot afford because of production schedule.

This abrasion was reducing the overall mass of the impeller and resonance was occurring for which the overall vibration was increasing again. As it was not possible then to overhaul

On inspection it was found that the wear of the impeller blades were increasing now at a faster rate. (Fig:10)

Figure 10. The impeller blades were wearing out at a faster rate

For the third time again the impeller was balanced by adding weight 1310 gms. and after adding the mass overall vibration reduced.(Table:6)

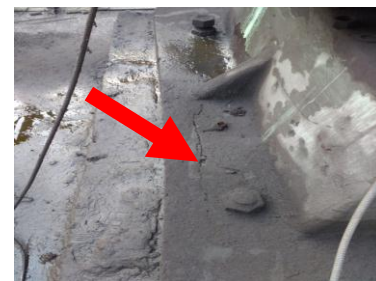
After the third balancing, the impeller had to be balanced further two times for the same reason but during the 5th balancing it was observed that due to frequent high vibration the fan base was getting damaged

and if the same is not contained the damage of the cast base will be irreversible. (Fig:11)

Figure 11. Initiation of Crack Propagation at the Base

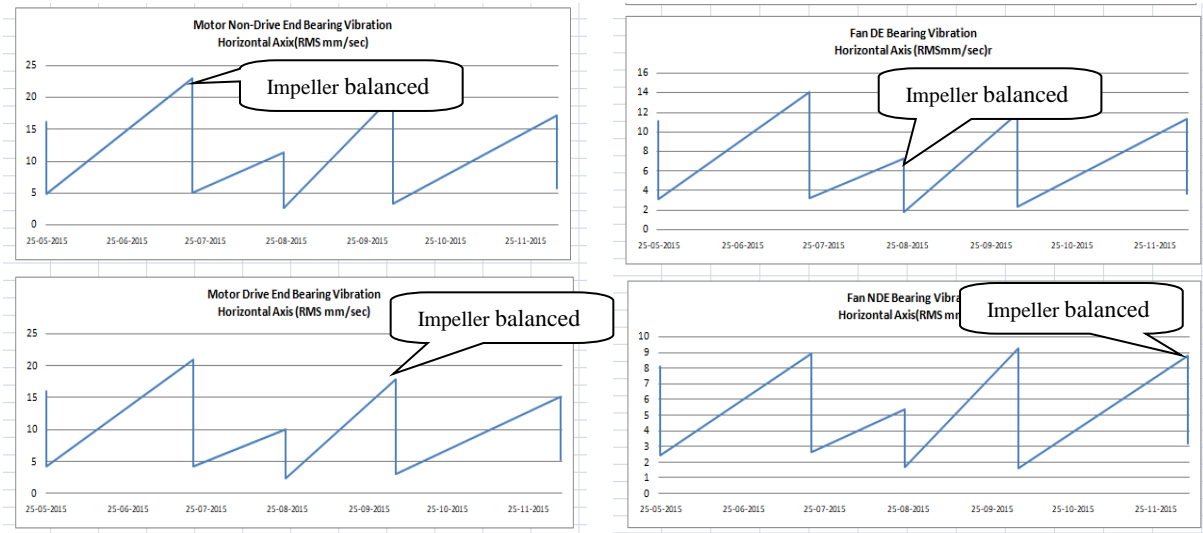
Figure 12. Horizontal vibration of the motor & the fan DE & NDE bearings after each balancing.

From the above graphs it is evident that the mean time between failures was as low as 45 days on the average and this was due to the fast wear rate of the impeller blades due to abrasion of the dust effusing from the partially damaged pollution control unit filter bags.

The reason for fast rate of wear of the impeller blades was found after checking the impeller blade material grade as

given in the general drawing supplied by the overseas original equipment manufacturer. The fan blade material specification was Q235B whose IS equivalent is IS: 2062 which is a common structural steel material but is not suitable for abrasion resistance.(Table:7)

From the Manganese % it is evident it is not a abrasive resistant material and not suitable for an impeller blade which is subjected to high velocity abrasive particles. This was the reason for high wear out of the impeller blades.

2: Coat the impeller blade surface with abrasion resistant material to reduce erosion due to abrasion.

The 2nd. option was certainly better as to locate the damaged bags from a bundle of 2304 bags is by itself a mammoth task and even after replacing the damaged bags there is no guarantee that other bags in due course of time will not get damaged in phases and start the process of corrosion. Routine damages of filter bags occur due to aging of the filter bags and natural deterioration due to common wear and tear.. So it was decided to coat the impeller blades with abrasion resistant material.

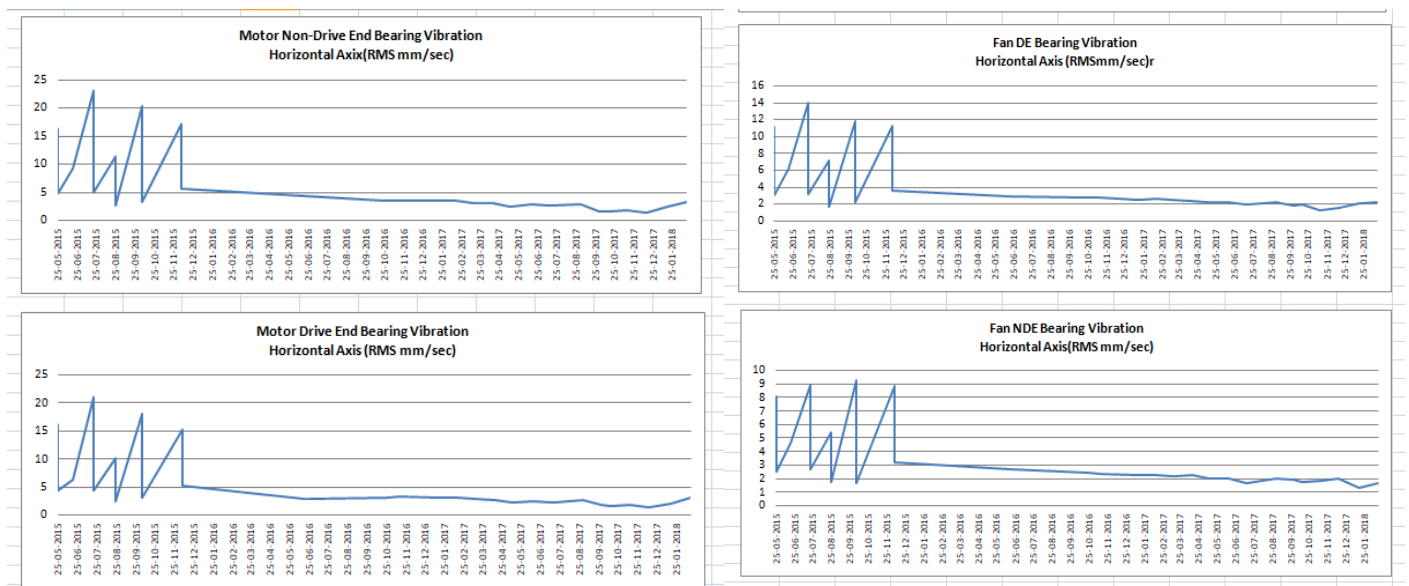
After the coating of the impeller blades fan has run uninterrupted for more than two years and monitoring done during schedule maintenance showed that all the vibrations were well within the acceptable range[1].(Fig:13)

Figure 16. Motor & Fan’s DE & NDE Bearing Horizontal Vibrations after Abrasion Coating Till 2018

Based on the base metal of the blades an abrasion resistant electrode [8] was selected with the following description:

After coating the impeller blades the total weight of the electrodes added was 35 kg. After checking the final balance the fan was commissioned on 16th June 2015. And reading taken before and after the final balancing is given in Table :7
