The Structural Behavior Of 4-Storey R.C Frame With Brick Infill

Abstract-This project studied the structural behavior of a quarter scale three bay four storey RCC frame with brick infill in the central bay with cyclic loading. Normally brick infill contributes as shear wall up to failure and subject to diagonal failure. An attempt was made to extend the reinforcement from the columns of the frame to the brick layers and embed with concrete to form a monolithic RCC strip to strengthen the interface of infill walls and RCC frame. This reduced diagonal crack in the infill. The frame was subjected to cyclic loading to stimulate the earthquake. The effect of infill on load carrying capacity, deflection, energy dissipation, stiffness, and ductility were investigated. The crack pattern showed that the potentially adverse effect of the infill was nullified and the frame was ductile in nature.

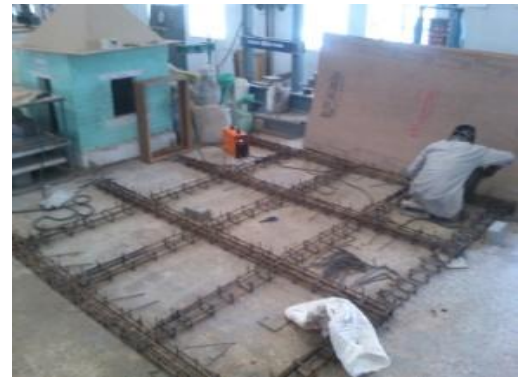
Fig.1. Reinforcement Detailing

Six numbers of 10mm bars were used for columns. Two numbers of 10mm RTS at bottom and two numbers of 8mm RTS were used in beams. 8mm RTS were used as stirrups and ties for both beams and columns. Two numbers of 6mm MS rods were used in the 20mm thick concrete in between the two layers of brick work. The reinforcement details were shown in table 1. Fabrication of reinforcement for frame was shown in fig. 1.

Section	Width	Depth	Main reinforcement	Bar Diameter	Stirrups	Detail
Beam	100	150	2 Nos	8mm(Top) 10mm(bottom)	8mm ϕ a @100mm c/c	 
column	150	100	6 Nos	10mm	8mm ϕ a @100mm c/c

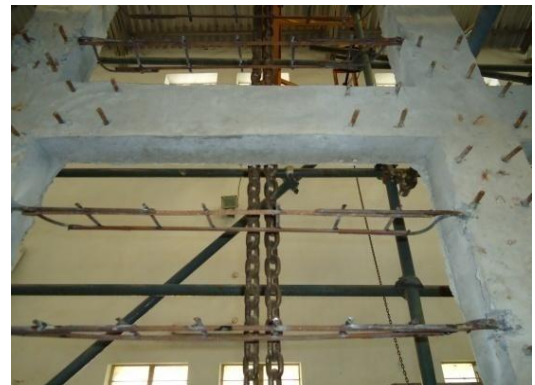
Fig.2. reinforcement strip

The frame was cast using M₃₀ concrete mix. Test cubes of size 150x150x150mm and prisms of size 100x300mm were cast. The test specimens were tested after 28 days curing and compared with the specified strength and found to be satisfactory. The frame was erected on the test floor. The reinforcement strip was as shown in figure 2.

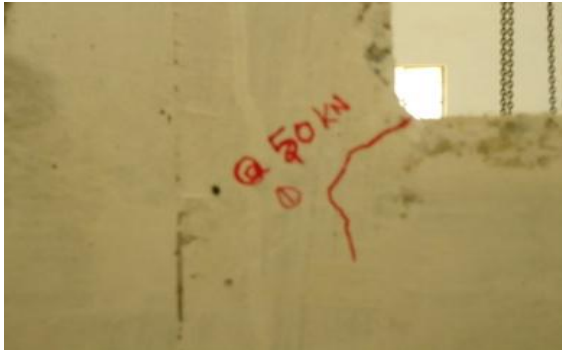
Fig.8 (a) Initial crack at the joints

At 40kN load initial minor cracks were found at the beam-column joints of the frame. At 50kN the cracks further developed for a length of 3-4cm as shown in fig.8 (a).

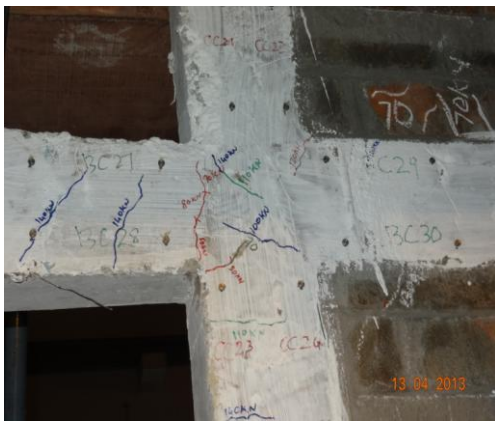
Fig.8 (b) Cracks at the joints

Increasing the load, budding major cracks (fig.8 (b)) were found and the concrete strain was not noted further. At 90kN few minor cracks developed in the brick layers for 2-4mm length in the bottom storey.

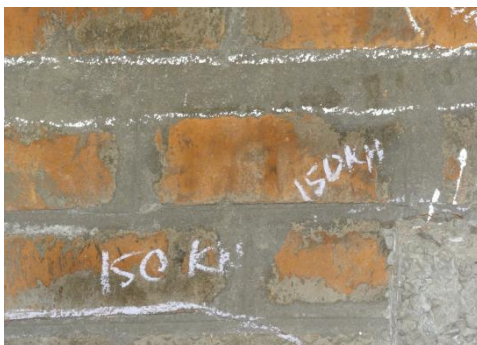
Fig.9. Occurrence of cracks in brick layers

At 120kN minor cracks were found in the bottom of the foundation in the tension side of the frame. At 150kN horizontal cracks were found in the brickwork as shown in fig. 9. At 173kN the wind ward column failed due to short column effect as shown in fig. 10.

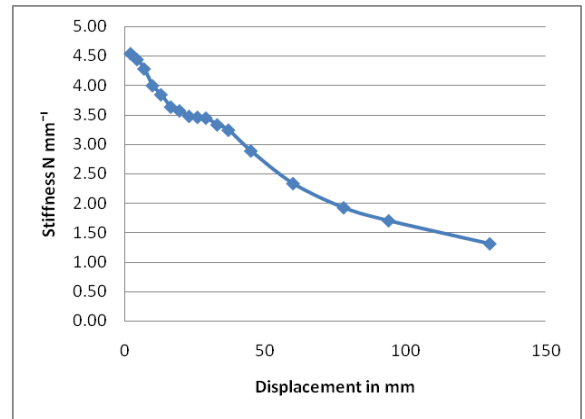
Fig.14. Stiffness vs. Displacement

Stiffness degradation was found to be steep till 10mm deflection and it was gradual beyond this displacement. This was obtained due to monolithic action of the frame and the brickwork. The brickwork contributed more to stiffness in the initial stages. When the crack occurred in the infill the stiffness was getting reduced. The mathematical expression of the stiffness degradation curve was $y = -2E-07x^3 - 0.000x^2 - 0.046x + 4.538$ and $R^2 = 0.987$. The Stiffness curve was shown in Fig.14.
