Diagnosis Of Stator Winding Of Induction Machine Using Hysteresis Curves Based On Maximum Partial Discharge Magnitude

T Elayaraja¹ and S.Natarajan²

School of EEE, SASTRA UNIVERSITY

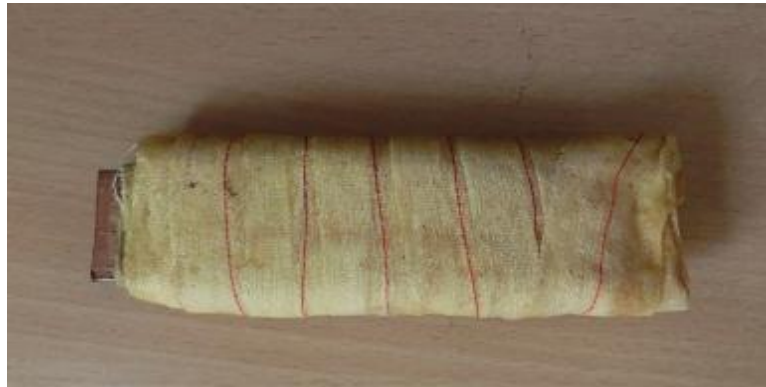
Fig.1 Test sample

Copper bar wound with cotton tape was used as test specimen. Cotton tape inherently is porous in nature. Initially approximately eight turns of a cotton tape was wound on the copper bar. When tested due to high content of pores it invited a huge leakage current. Hence cotton tape was impregnated with insulating varnish and dried for one day. A conducting aluminum foil is wound over the cotton tape to be connected to ground. Copper bar was connected to HV electrode and aluminum foil was connected to ground so that applied voltage falls across the insulation. Four different samples with simulated faults were made. The healthiness of the insulation can be checked by applying high voltage across the insulation and measuring the PD magnitude. From the control panel the voltage was applied to the test transformer and from the test transformer the voltage was applied to the test specimen. Initially the Discharge Inception Voltage DIV was noted for the healthy specimen. Then voltage applied was increased in steps and each time the maximum peak value of PD was measured. This process was continued till the PD data in PD meter exceeded out of range limit.

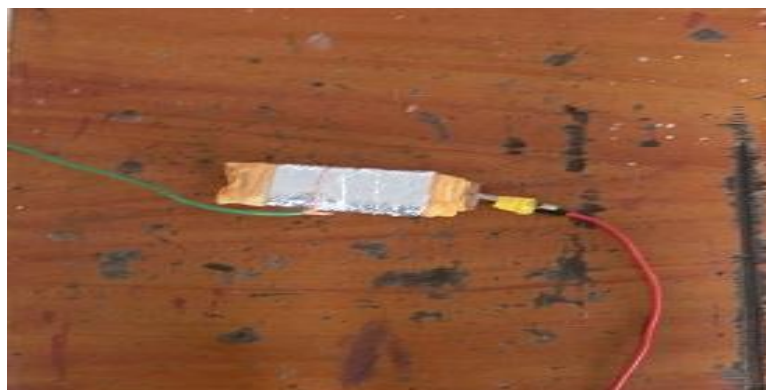
Fig.2 Connection in laboratory

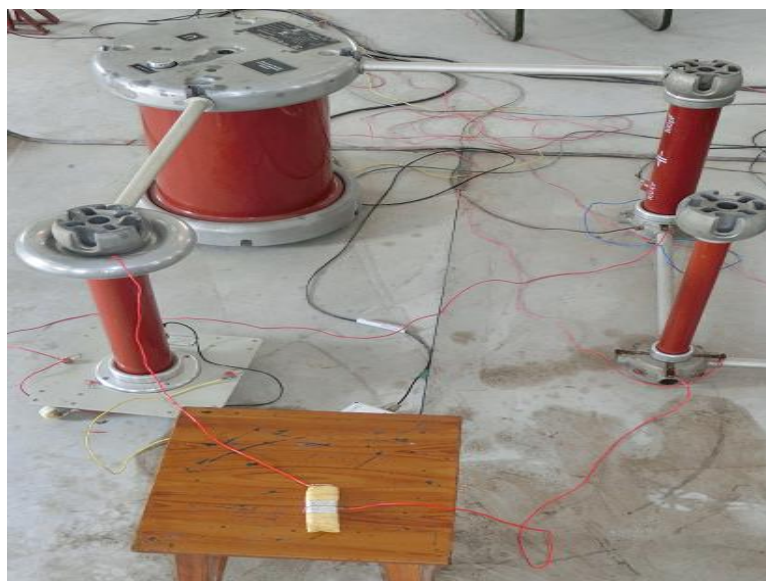
Fig.3 Laboratory setup

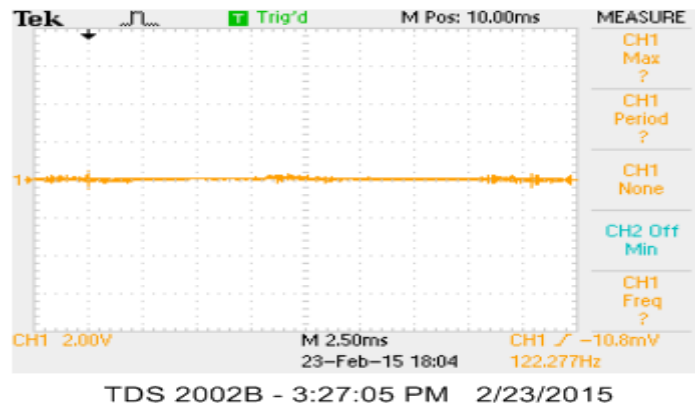
Fig.4

P.D recorded at 3.9kv

Above results were tabulated as obtained from the P.D meter[2]. P.D first occurred for good specimen at 3.9kV. Then the P.D recorded at 6.92kV, where the Partial Discharge magnitude was high when compared to result obtained at 3.9kV. For each voltage applied to the specimen the maximum Partial Discharge magnitude was recorded in Pico Coulombs. In PD meter the range was set at 50 pC. Voltage was increased up to 10kV, above which the PD magnitude went out of range. PD patterns observed from meter showed significant difference for different defects[6].The results obtained at 10kV showed dense crowded PD compared to previous readings.

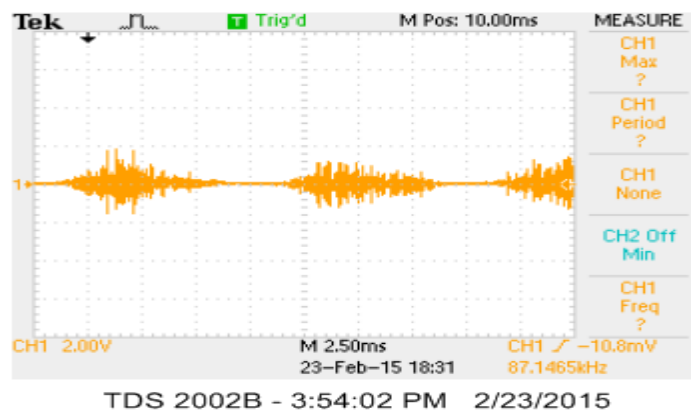
Fig.6

P.D recorded at 10kv

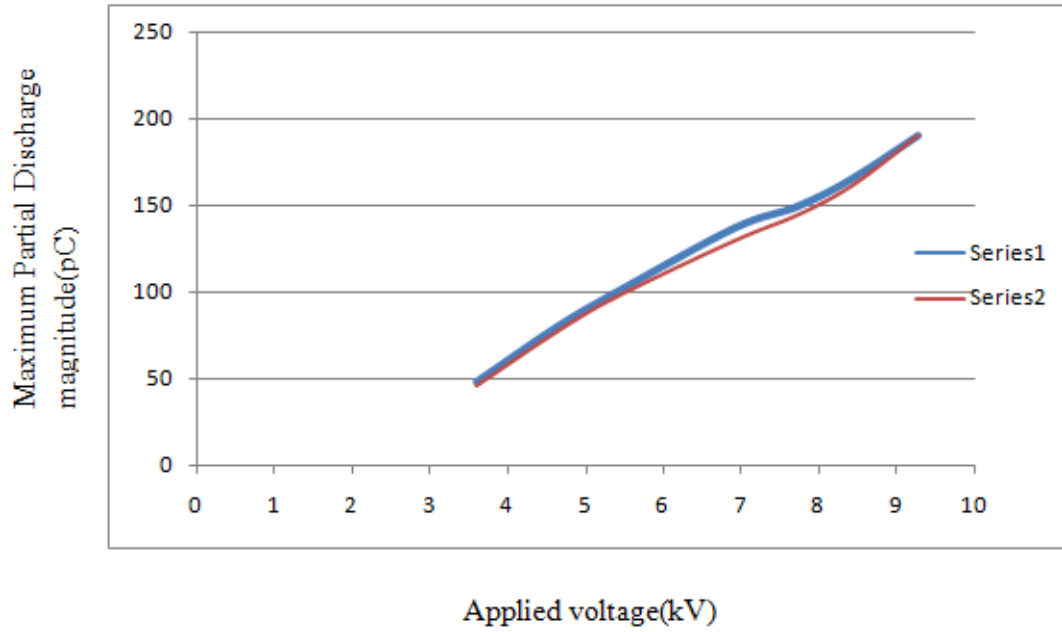
Fig.7 for good specimen

From the plotted graph it was observed that area between the up curve and down curve was found to be comparatively small for the healthy specimen[1]. Partial Discharge is a statistical phenomenon, so the curve obtained while the voltage is decreasing may go upward than the curve obtained while increasing the voltage, there is no usual behavior in this case[5]. The gap between two curves decides the quality of insulation. It is also clear that specimen which is stressed more shows more discharges than the healthy one. Experimental arrangement and measurement is comparatively easier in this method. This method is applied to the model copper bar specimen.

Tests have been performed on good specimen without any simulated faults, and on specimens with simulated faults such as thermal ageing, a void in the insulation, fault due to surface glazing. All the three faulted specimens on test showed larger areas in hysteresis curves developed compared to good specimen. But the areas were found to be different for different faults. If the area between two curves is large then the condition of the insulation of the bar is in bad state, Whereas if the area between two curves is small then the condition of the insulation is in good state. This method can be applied for rotating machine stators and the healthiness of insulation and its residual life can be reasonably predicted.

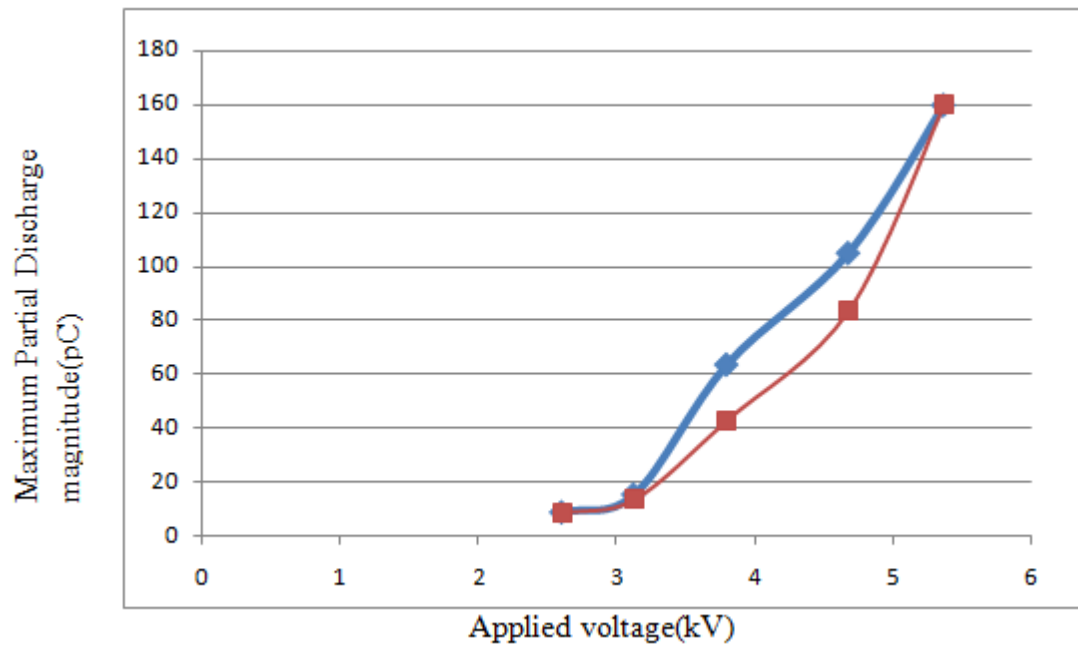
Fig.8 thermal aged specimen
