## **Experimental Investigation In CFRP For Application In Retrofitting of Diaphragm Wall Structure**

### **Abstract**

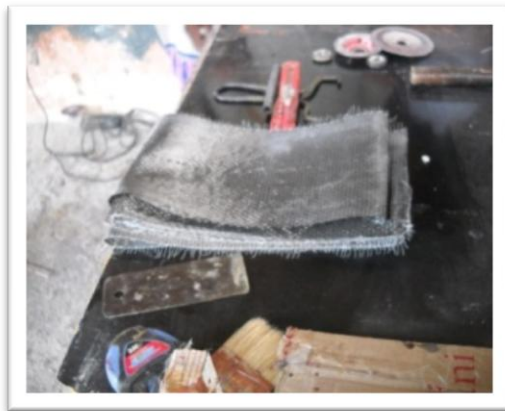
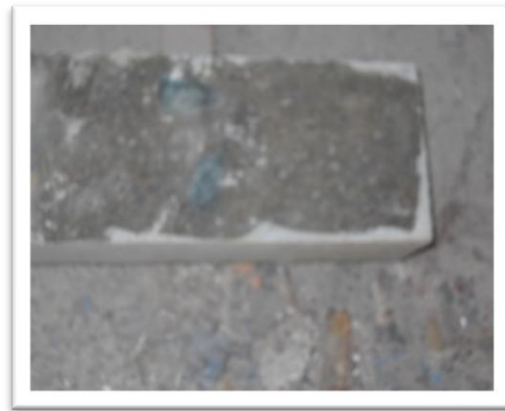
**Figure 3:** (a)CFRP Sheet (b)Surface Preparation

bottom surface of the cured beam. Surface of the specimen made to roughen by machine and cleaning have been done on all the specimen. The cleaned surface has been applied with polymer resin epoxy and hardener. Hand mixing has been performed. After this surface preparation, CFRP sheet has been pasted on the bottom surface using adhesive. Following this steel rollers were pressed over the specimen to remove the air voids. It should be cured for 3 days after the bonding stage over.

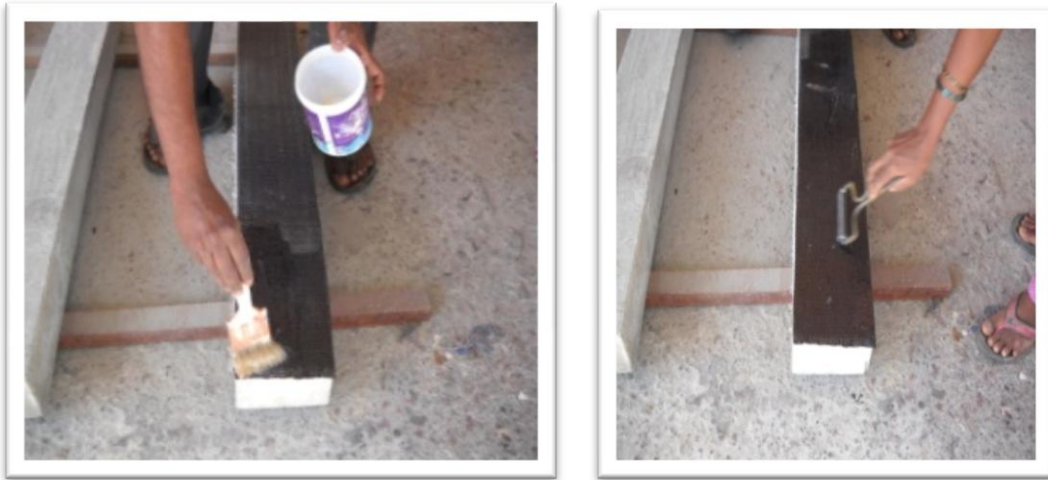
**Figure 4:** CFRP on the bottom of the beam

RC Samples has been kept cast and cured for 28 days. After its curing has been over, application of CFRP sheets works will be initialized. Retrofitting should be done in

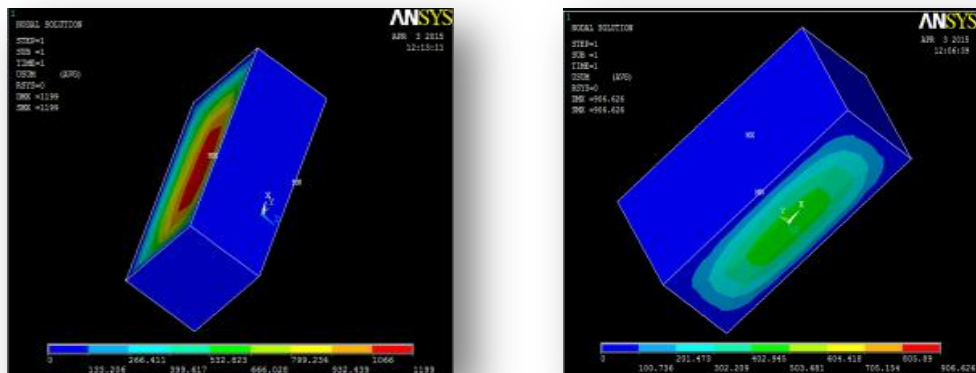
**Figure 8:** Deformation Analysis

Finite element analysis has been done to model the diaphragm wall Structures. ANSYS Software is used for the deformation analysis. Analysis is done for Reinforced concrete wall with externally bonded CFRP.

a. Diaphragm wall without CFRP

b. Diaphragm wall with CFRP
