## **Investigation on Structural Behaviour of R.C.Columns Subjected To Steel Corrosion Under Loading**

This paper examines and analyzes the test results produced from a comprehensive test program designed to study the axial behaviour of reinforced concrete columns subjected to steel corrosion. A total of thirty scale model circular columns (150 mm diameter and 300mm height) were tested. The primary variables of this investigation were the sustained loadings, different degrees of steel corrosion and position of longitudinal reinforcement. A direct current was applied to accelerate the corrosion process. Open circuit potential (OCP) and direct current polarization resistance were obtained to evaluate the steel (rebar) corrosion. Axial behavior and residual loading of the columns were measured at the end of the experiment. In addition Non-Destructive Test (NDT) were conducted to assess the condition of corroded concrete. Chloride content in the cover concrete was found out by the standard titration method. Uncorroded columns were used as control samples and tested in parallel with the corroded samples. The results indicated that when 8 percent of the mass of steel is corroded the ult

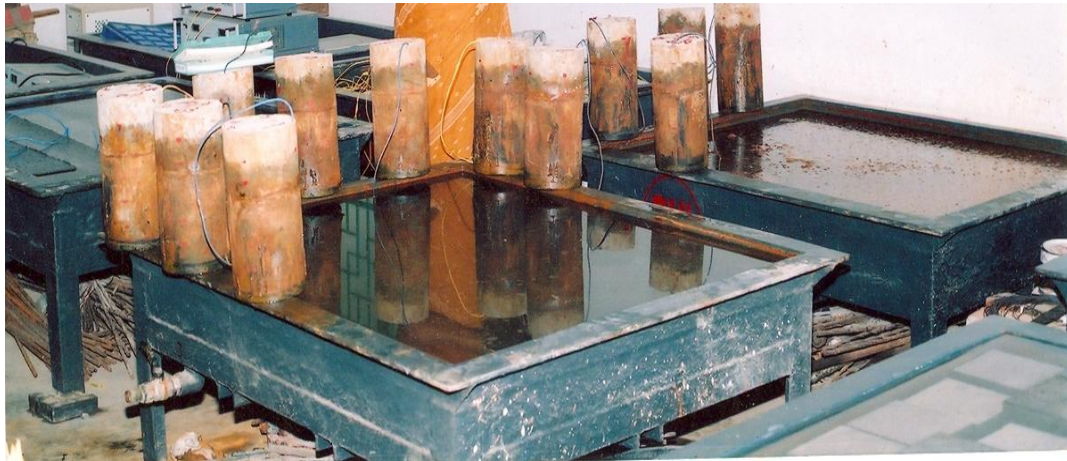
**Figure 3:** Scale Model Columns After The Accelerated Corrosion Process

the top and the other at the bottom of the specimens and the whole assembly is tightened with threaded rod and nuts which was controlled by a torque wrench. Figure.2. gives the schematic arrangement of the sustained load corrosion process. The load decreases as the corrosion proceeds (Creep effects) with increase in time. To maintain the loads constant throughout the duration of the test, continuous monitoring and adjustment of nuts were required. The steel plates, nuts and bolts were coated with Zinc – copper alloy to avoid the galvanostatic corrosion. Figure.3 and Figure.4 shows the specimens after the accelerated corrosion process.

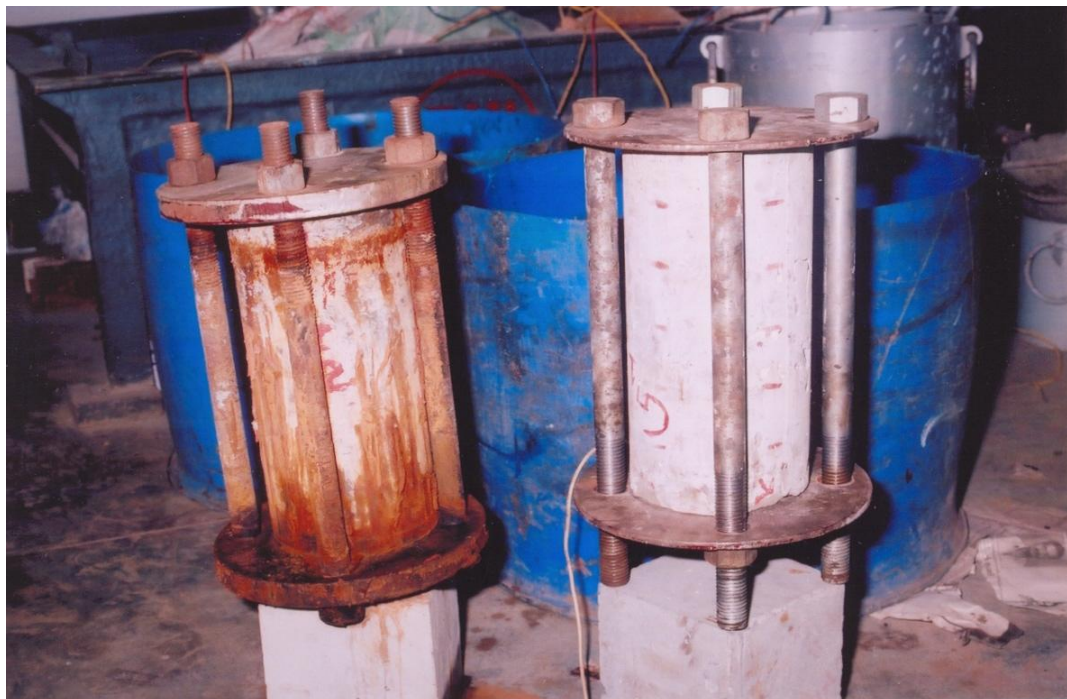
**Figure 4:** Scale Model Columns After The Accelerated Corrosion Process Under Loading Condition

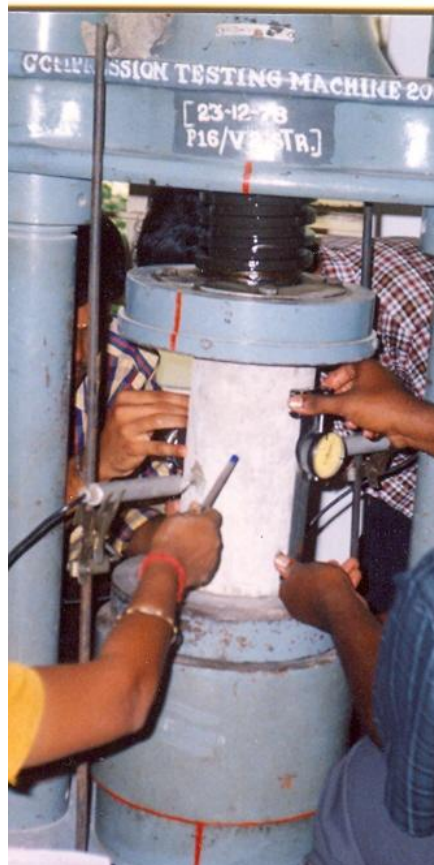
**Figure 7:** Concentric Axial Load Test Conventional Specimen

Axial compression test were conducted after completion of the accelerated corrosion process, and the obtained failure load and failure modes are summarized in Table 3. Axial strain was measured using demountable mechanical strain gauge which is positioned at diametrically opposite sides of the specimen. Figure.7 and Figure.8. shows the test set up of conventional and corroded columns. The failure of conventional columns occurred due to the cracking and spalling of the concrete cover. Figure. 9. shows the failure pattern of conventional column. However, it was noticed that the spalling of the concrete cover of the corrosion damaged columns occurred along the height of the columns (Figure. 10. shows the state of failure of the corroded specimen) almost at the same time, showing significant loss of failure load as compared to the conventional column. This is probably because the concrete cover of the corroded column were already delaminated , prior to the failure tests, due to the cracks formed around the spiral reinforcement and cross-sectional loss of steel reinforcement. From the Table 3 it can be seen that R2 specimens which has higher load carrying capacity than R1 specimens because of increased percentage of area of reinforcement. For 33 % increase in the area of reinforcement the percentage increase in load in AR2UC is 6.02% than AR1UC specimen. The percentage decrease in the series AR1C1, AR1C2, AR1C3 and AR1C4 are 15.38%, 29.10%, 39.48%and 45% respectively with respect to control specimen, whereas those noted in the series AR2C1, AR2C2, AR2C3 and AR2C4 are 12.40%, 26.51%, 35.06%, and 40 %respectively with respect to control specimen. For the same level of corrosion the percentage decrease in the load noted in AR1C4 is 35 % with respect to AR1C1, whereas 31.49% is noted in AR2C4 with respect to AR2C1.

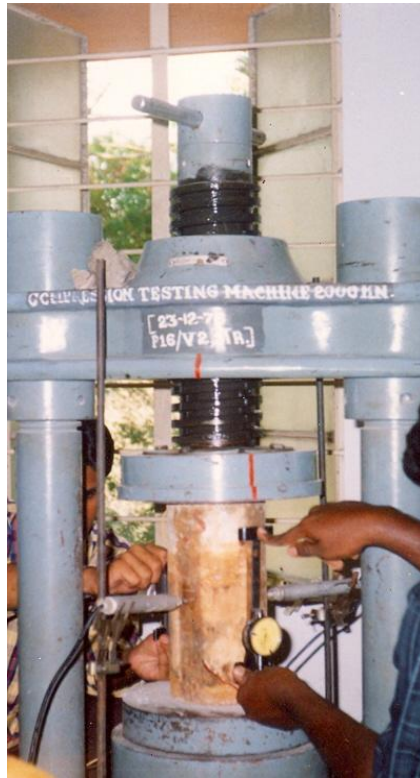
**Figure 8:** Concentric axial load test Corroded specimen

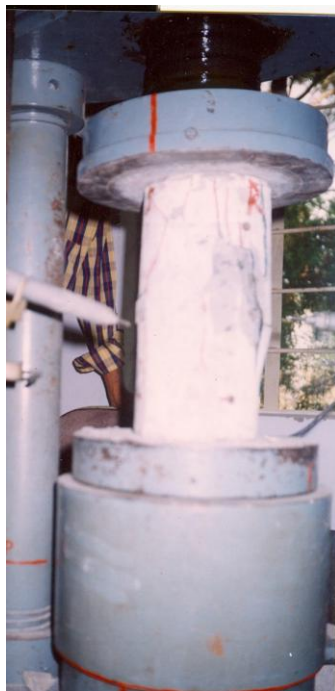
**Figure 9:** Failure mode of Conventional specimen

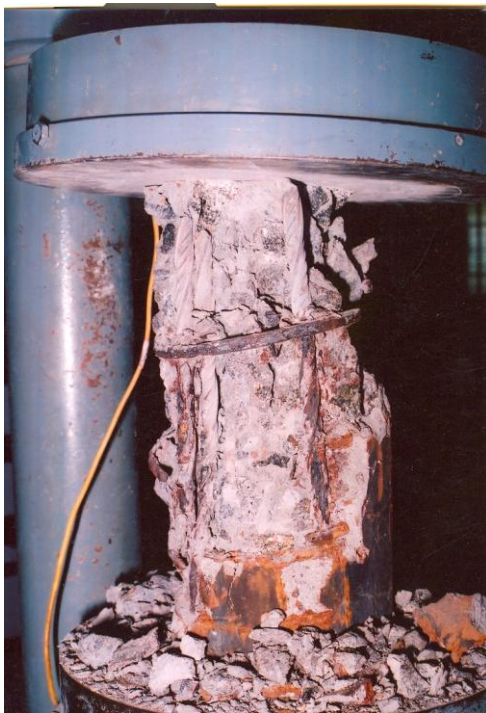
**Figure 10:** Views of failure of the specimen.
