Video Evidence Appraisal Using Changing Keypoints: A case study

Abstract

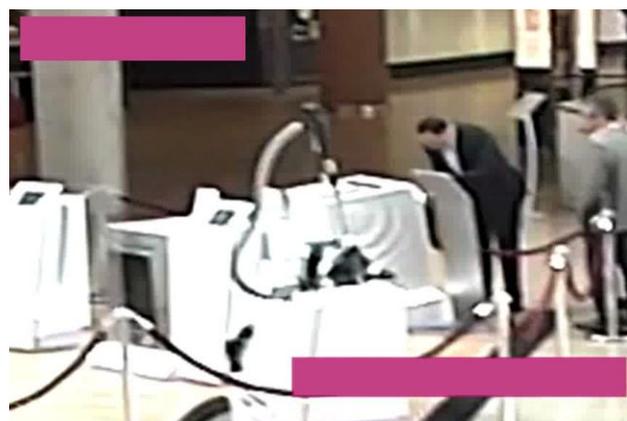
Figure 1. The scene that Bob is touching washing machine at the CES.

Alice (the staff of Consumer Electronics Company A) filed a lawsuit accusing Bob (the staff of Consumer Electronics Company B) of property damage and obstruction of business. “ Fig. 1,” That is, Alice accused Bob of intentionally damaging the washing machine by pressing the door. Later, Alice and Bob arrived at an agreement. Nonetheless, the prosecutor of this case continued to investigate this case because obstruction of business falls under a category of “no punishment against will”. The evidence at issue was the video taken by the staff after Bob left.

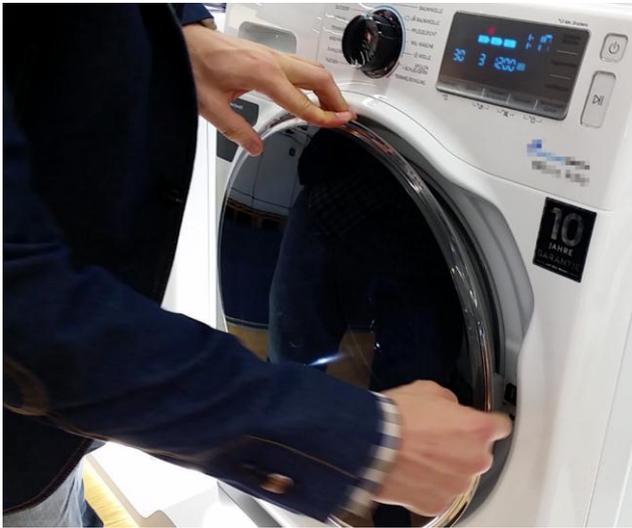
In this video, the staff tried to close the door but to no avail. This video could be accepted as evidence in court to prove that Bob broke the door of washing machine. However, the defendant argued that the shop staff seemed to have pressed the door in this video. Thus, a thorough analysis was required. Therefore, it was required to ascertain the truth of the scene that showed the door of washing machine and the hand of shop staff who was pressing the door downward. The purpose of this step was to determine whether the shop staff in the video broke the door by pressing the door of washing machine downward.

Figure 2. The staff tried to close the washing machine door.

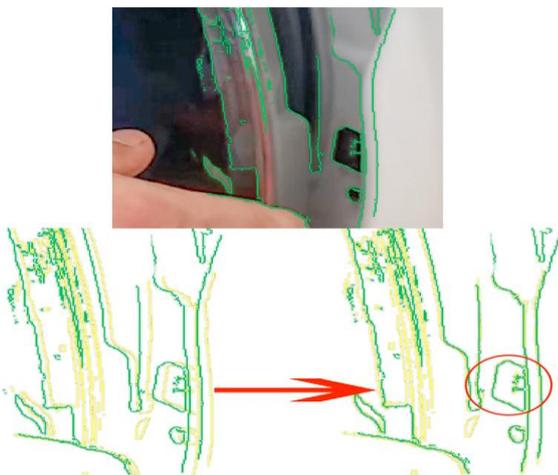
To track down the trajectory at which the door of washing machine swings open and closed, this paper selected a certain part of the washing machine as a fixed keypoint that could serve as a point of reference. Moreover, this paper selected a part of the door of washing machine as another keypoint that could be compared with the point of reference. In other words, this experiment analyzed the moment in which the shop staff opened and closed the door of washing machine. The right and left movement of the keypoint at the door of washing machine can be regarded as the natural trajectory at which the door swings open and closed. However, if there is a section of rapidly changing up and down movement in the keypoint at the door of washing machine, this particular section implies that the shop staff applied force down to the door from top to bottom when swinging the door open and closed.

Figure 3. Realignment of edge.

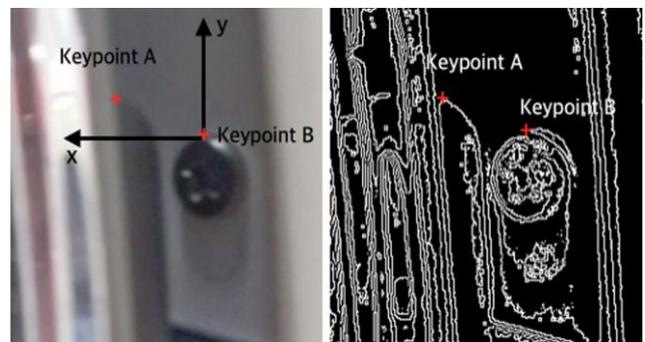
To analyze this section, (1) 72 frames were first extracted from this section with duration of 2.42 seconds was first extracted. (2) The contour line of door was then extracted through canny edge[3]. (3) Two keypoints were chosen in the frame in which the contour line was extracted. (4) In these 72 frames, a moving keypoint (Keypoint A) was set at the top of door hook and a fixed keypoint (Keypoint B) was set at the top of latch hole. (5) The frame position of 72 footages was realigned in accordance with Keypoint B. (6) Lastly, the x- and y-coordinates of Keypoint A were derived. X-coordinate varied in the horizontal direction, whereas y-coordinate varies in the vertical direction. As a result, Keypoint B is fixed in the realigned frames. Therefore, the value of y of Keypoint A must be constant or similar unless physical force is applied to Keypoint A.

Figure 4. Selection of keypoints A and B.

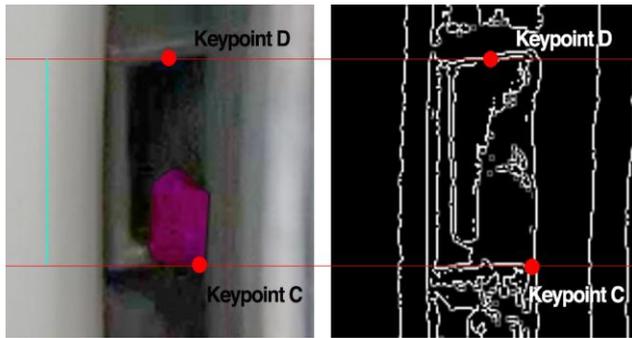
To analyze this section, (1) 66 frames were first extracted from this section with duration of 2.9 seconds was first extracted. (2) The contour line of door was then extracted through canny edge. (3) Two keypoints were chosen in the frame in which the contour line was extracted. (4) In these 66 frames, a moving keypoint (Keypoint C) was set at the bottom of door hook and a fixed keypoint (Keypoint D) was set at the top of latch hole. (5) The frame position of 66 footages was realigned in accordance with Keypoint D. (6) Lastly, the change of the distance was measured between Keypoints C and D in 66 frames.

Figure 5. Selection of keypoints C and D.

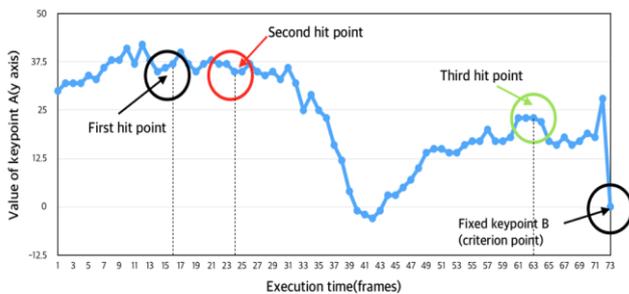
“ Fig. 6,” is the schematic view showing the value of y, which is the vertical displacement, in chronological order. Among the 72 frames, Frame No. 16, Frame No. 24 and Frame No. 63 were the sections in which the shop staff hit the door hook to the bottom of latch hole once. However, the value of y in Frame No. 63, in which the shop staff hit the door hook to the bottom of latch hole for the last time, was lower than the values of y in Frame No. 16 and Frame No. 24.

Figure 6. Unusual points according to time passage.

In the first two sections in which the shop staff hits the door, the values of x and y of Frame No. 16 (65, 37) and Frame No. 24 (60, 35) were similar to each other. However, the values of x and y of Frame No. 63, in which the shop staff hits the door for the last time, were 65 and 23, respectively. That is, the value of y of Frame No. 63 was substantially lower than the values of y of Frame No. 16 and Frame No. 24. In other words, the analysis reveals that the door could not be closed properly because the door of washing machine was moved down due to the force of shop staff, which could be seen in Frame No. 63 in which he shut the door for the last time.

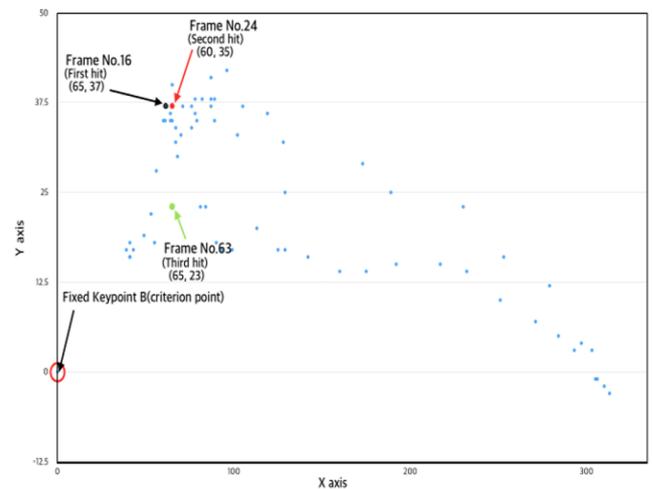
“ Fig. 7,” shows the values of x and y of Keypoint A of the door in the 72 frames. It was confirmed that there was a movement in the vertical direction even when the angle at which the door swung open remained similar (that is, the x-direction displacement was identical). On this account, this finding indicates that the shop staff repeatedly pressed and released the door downward while swinging the door of

Figure 7. Analysis of Keypoint A.

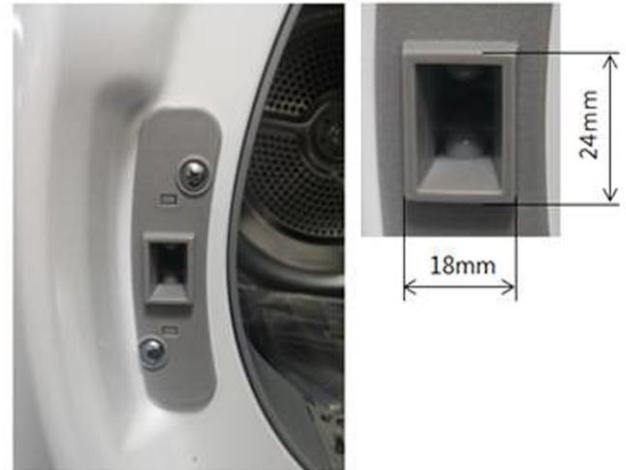
Figure 9. Real size of latch hole

“ Fig. 9,” The real length of the latch hole was 24mm, and it was about 20 pixels in the analyzed video. As an analysis result of (1), the y value of No. 63 frame is between 12 and 14 pixels smaller than No. 16 frame, No. 24 frame. That is, the difference of No.63 frame's y value is big enough to form half of the latch hole. So if the shop staff didn't put power on the washing machine door, the door could have been closed.

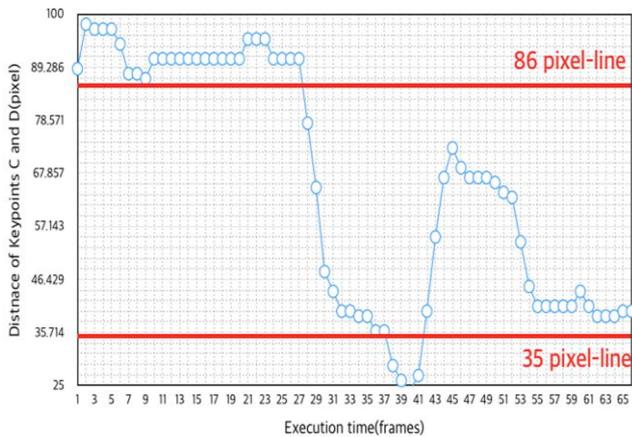
“ Fig. 8,” After measuring 66 frames, the distance between keypoints C and D showed remarkable changes. The distance of No. 1 to No. 28 frame was longer than 86 pixels, the ones

between No. 29 to No. 37 and No. 42 to No. 66 were between 35 and 86 pixels, and the one between No. 38 to No. 41 was measured shorter than 35 pixels.

Accordingly, the frame between key points C and D was measured as between 35 and 86 pixels. These frames are the section where the washing machine door can be closed well enough. However the frames over 86 pixels and under 35 pixels might not be able to close the door well. In other words, because the shop staff closed the door while pushing it from the top, it was measured as a section out of the normal range.

Figure 8. Analysis of distance between keypoints C and D
