# A Review on Failures of Industrial Components due to Hydrogen Embrittlement & Techniques for Damage Prevention

## Abstract

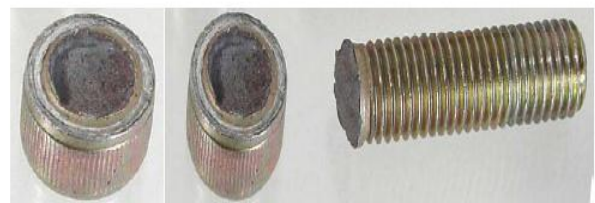
**Figure 1.** Typical Fastener Failure by Hydrogen Embrittlement [8]

High strength mechanical steel fasteners are broadly characterized by tensile strengths in the range of 1,000 – 2,000 MPa (150 – 300 ksi), and are often used in critical applications such as in bridges, vehicle engines, aircraft, where a fastener failure can have catastrophic consequences. [7]When high strength steel is tensile stressed, as is the case with a high strength fastener that is under tensile load from tightening, the stress causes atomic hydrogen within the steel to diffuse (move) to the location of *greatest stress* (e.g., at the first engaged thread or at the fillet radius under the head of a bolt). As increasingly higher concentrations of hydrogen collect at this location, steel that is normally ductile gradually becomes brittle. Eventually, the concentration of stress and hydrogen in one location causes a hydrogen induced (brittle) micro crack. The brittle micro crack continues to grow as hydrogen moves to follow the tip of the progressing crack, until the fastener is overloaded and finally ruptures.

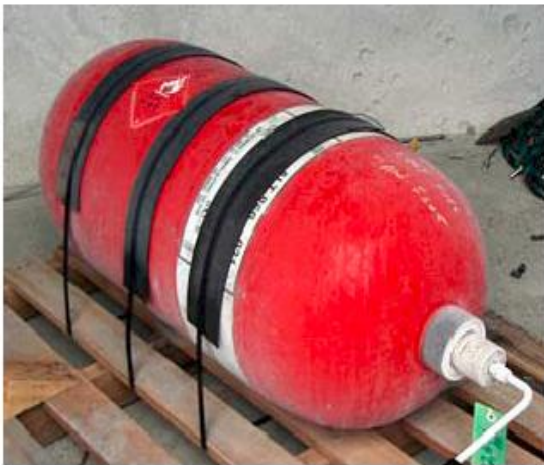
Figure 2. High Pressure Hydrogen storage tank [6]

A first example is the failure of a storage tank for compressed hydrogen. The consequences of this can be ascertained from Fig. 1. This failure was caused by the growth of large fatigue cracks which was induced by hydrogen insurance. The total damage paid by insurance in this case was approximately US\$50 million. Hydrogen damage is more frequent than many people would suspect.
