# Causes of Coastal Erosion and Environmental Damage on the Sowan Beach of Tuban District

Marita Ika Joesidawati<sup>1)</sup>, Suwarsih<sup>1)</sup>

<sup>1)</sup>Program Study of Marine Science, Faculty of Fisheries and Marine Science, Universitas PGRI Ronggolawe, Tuban, Indonesia.

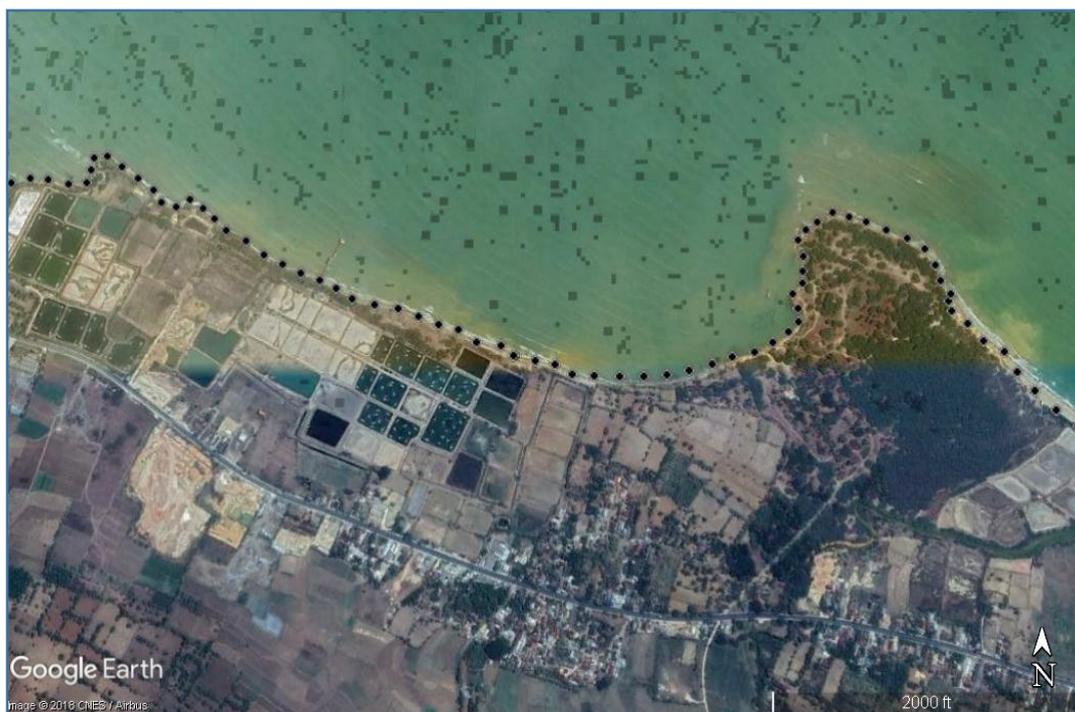
**Figure 2.** Location points (70 location points) for observing the causes of coastal erosion

where there are 70 locations that are 50 m away from one point to another.

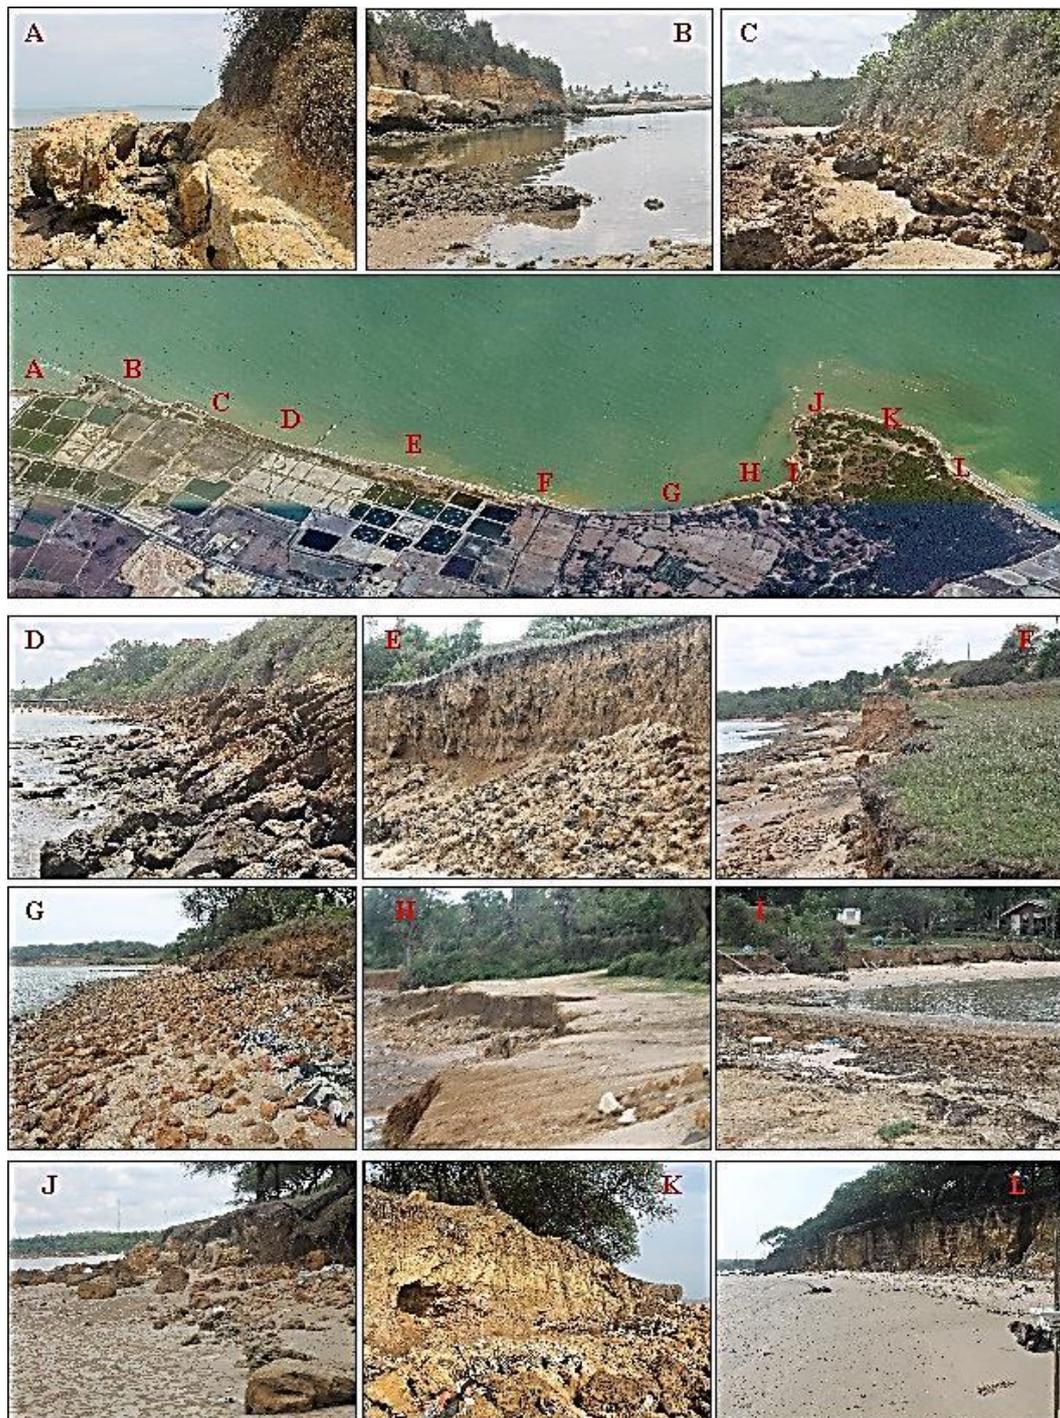
using 6 parameters; sand mining, coastal reclamation, groundwater consumption, land use patterns, protection of nature, coastal structures. Human activities can increase the negative impact of rising sea levels and also have an impact on the amount of erosion on the coast of Tuban district. However, in this study, seven parameters were added, including the presence or absence of data on watersheds in the study location. The erosion conditions around the Sowan Beach are based on field observations as shown in Figure 3

**Figure 3.** Multiple Point Samples Location of 2017 Field Observation Results on Beach Erosion Conditions along Sowan Beach ( $\pm 3.5$  km) (12 points from 70 points)

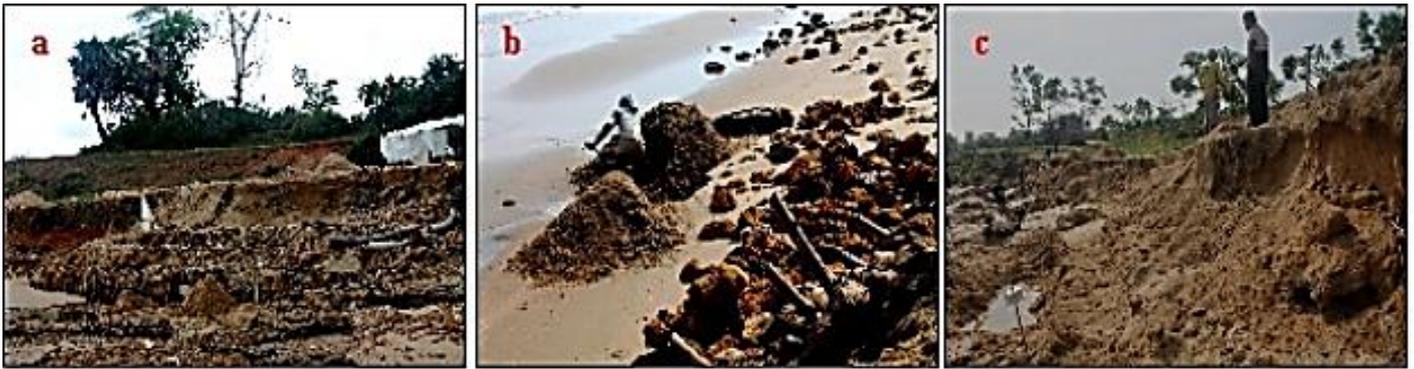
2016). Illegal sea-sand mining can affect coastal areas to be more vulnerable (Ozyurt, 2007). Figure 4 shows the illegal sand mining around the Sowan beach the research location) is located in Bogorejo village. The production of sea-sand in the mine are coordinated by sea-sand middlemen.

**Figure 4.** Illegal sand mining around Sowan Beach (Bogorejo Village)

Illegal sand mining around Sowan beach is 856.25 m or 30.98% of the length of the coast of Bogorejo Village, Bancar District. The beach vulnerability index using the vulnerability class from Joesidawati (2016) shows that sand mining in Sowan falls into the category of "vulnerable" class

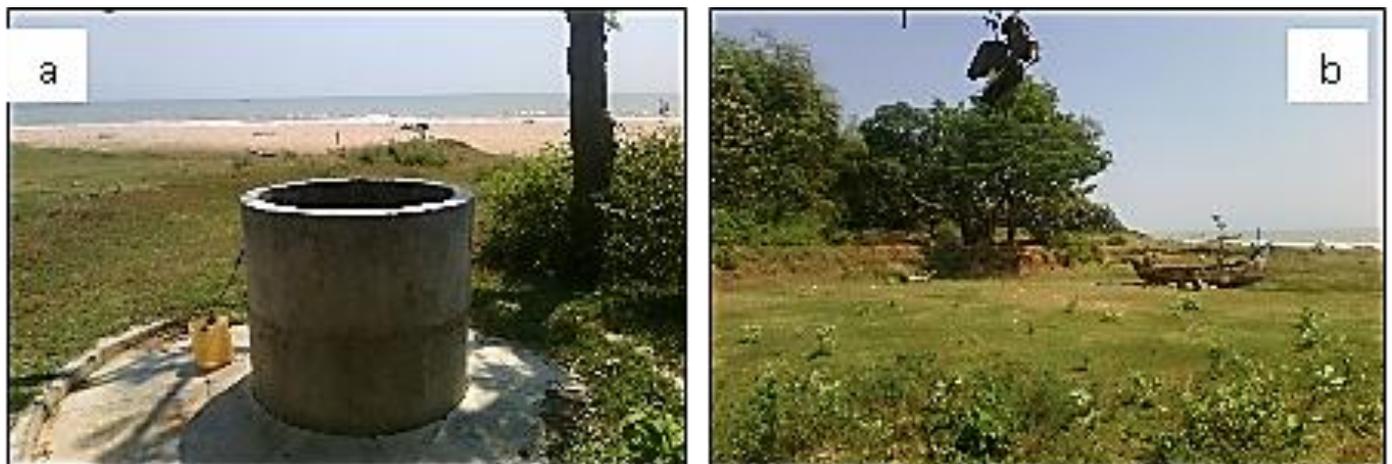
In this research area, clean water needs use two sources, it comes from sources originating from local water supply utility and natural resources in the form of private or village-managed wells. Based on data on groundwater consumption around Sowan Beach, it shows that 50% is used for agricultural irrigation and shrimp ponds. Whereas for the consumption of drinking water and the daily needs of the residents around Sowan Beach use the local water supply utility. The source of clean water for local water supply utility comes from several sources, it comes from spring and artesian wells. This condition indicates that groundwater consumption exceeds 50% or in the class "very vulnerable". Figure 5. Shows the location of artesian wells for agriculture around the Sowan Beach, the distance between one artesian wells to another is  $\pm 50$  m.

**Figure 5.** (a) The distance from the artesian wells along the Sowan coast is  $\pm 200-300$  m from the shoreline and (b) the distance between the artesian wells is  $\pm 50$  m

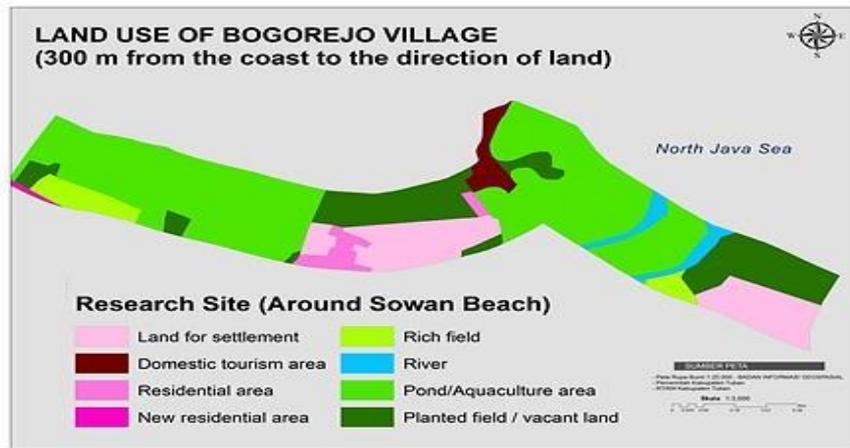
Figure 6. Land Use of Research Sites

Land use pattern in the study location was seen at a distance of 300 meters from the shoreline as shown in Figure 6

Figure 6 shows planted field / vacant land 153,854.54 m<sup>2</sup>, domestic tourism area = 20,995.61 m<sup>2</sup>, rice field = 34,235.30 m<sup>2</sup>, pond = 423,640.15 m<sup>2</sup>, river = 21,549.06, land for settlement = 145,885.86 m<sup>2</sup>. Based on the vulnerability class, this region shows the class of "vulnerable" this is because the agricultural area is 76.45% or 611,729.99 m<sup>2</sup>, residential area 18.23% or 145,885.86 m<sup>2</sup>, protected area 2.62% or 20,995.61 m<sup>2</sup>, unclaimed area of 2.69% or 21,549.06 m<sup>2</sup>

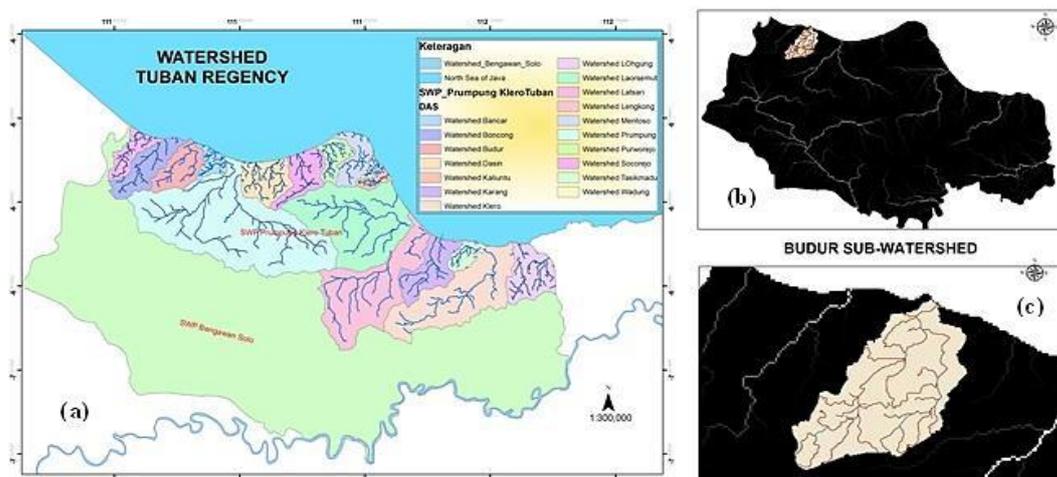
Figure 7. (a) Watersheds in Tuban Regency, (b) and (c) Budur Sub-Watershed which flow on Sowan Beach

Based on Figure 7, the Sowan beach is strongly influenced by the budur river flow. This condition shows that the class is "highly vulnerable"

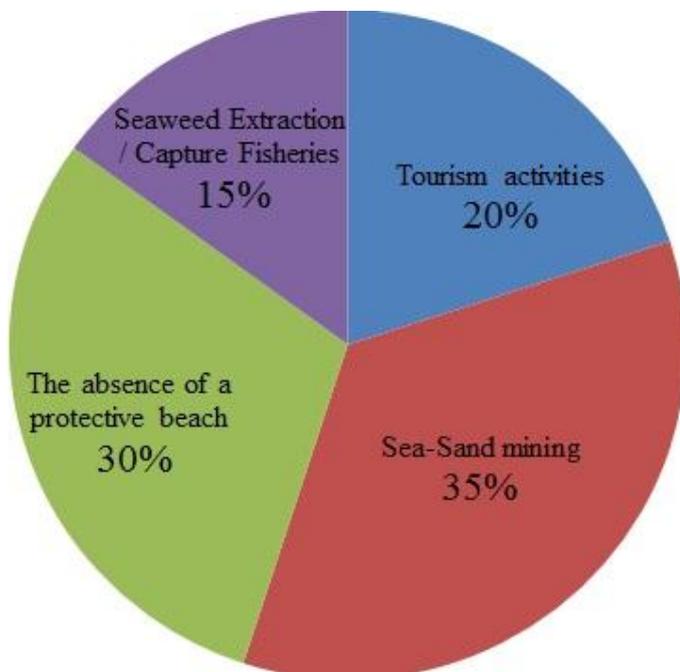
**Figure 8** Reasons for coastal erosion and environmental damage according to community perceptions

Figure 8 shows the causes of erosion and damage to the coastal environment from the point of view of the community around the Sowan Coast. According to analysing the results of questionnaires of 100 residents around the study area, one of the factors influencing the increase in coastal erosion intensity is the absence of coastal protectors, even though the community has informed that there is a need for coastal protection for local governments, but there is no right solution to reduce the situation.
