Identifying Flexible Pavement Distresses Using Spectro Radiometry Classification on Worldview 3 Images

Indira Pachón-Cendales MSc

Alexander Ariza-Pastrana PhD

Wilmar Fernández-Gómez PhD.

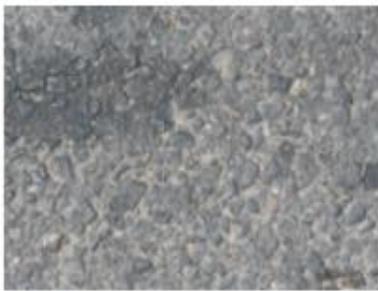
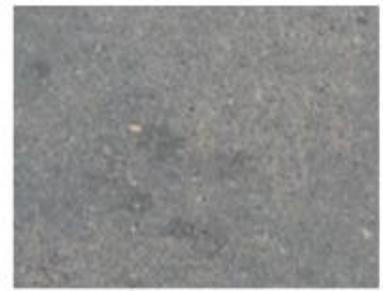
PCI: 46

PCI: 90

PCI: 54

Figure 2 Spectral signatures (Up) y Pavement deterioration (Down) 1) Ravelling high severity 2) new pavement 3) Ravelling low severity

Spectra 2 and 3 in Figure 2 are compared with a new pavement of an asphalt surface (2) and with a pavement that shows a slight loss of the asphalt layer (3) or aggregate outcrop (gravel). The crumbling exhibits a greater quantity of rocky components on the surface, which increases the gloss of the surface due to the increase in reflectance produced by the mineral component, presenting less prominent asphalt absorptions. Spectrum (1) reflects a gravel surface with more advanced deterioration. Compared to that of new pavement (2), this surface has higher reflectance in the visible and near-infrared due to the absence of absorption of asphalt hydrocarbons [7].
