# Educational Module for Ultrasonic Bearing Inspection

## Abstract

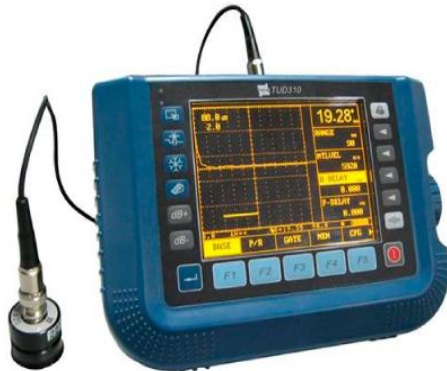
maintenance can detect faults at earlier stages than vibration analysis [9]. Figure 1 illustrates an ultrasonic detector for predictive maintenance, displaying the measured dB graph and average dB value for a specific time segment as a result of its measurements.

Figure 1. Ultrasonic detector [10]

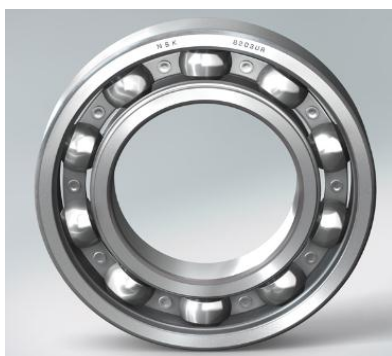
Figure 2. Bearing [11]

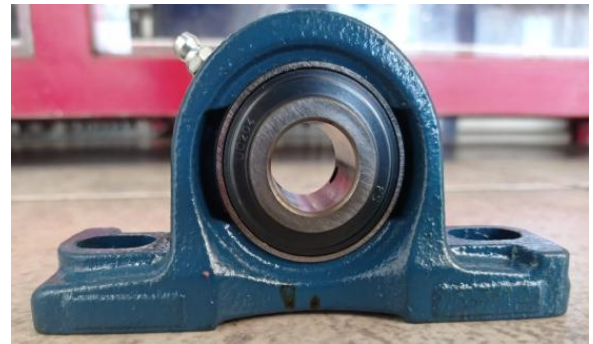
Figure 3. Support Mounted Bearing [11]

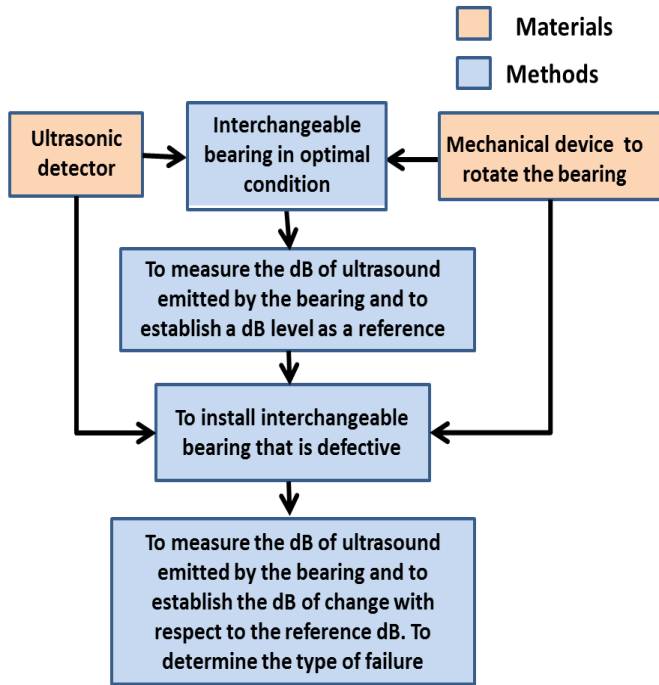
Figure 4 shows the block diagram of the materials and the methods used in the educational module for the ultrasonic bearing inspection. Initially, four new and identical bearings from the same manufacturer and model are used, each of them in optimal condition. One bearing is kept in its original condition to establish the reference dB level. The other three bearings are intentionally damaged: one is contaminated with dust, another is degreased of lubricant, and the last one is immersed in water to cause oxidation. A mechanical device was developed to rotate the bearing under inspection, allowing for easy exchange of bearings to determine the type of fault they present. As shown in Figure 4, the bearing in good condition is installed in the mechanical device, and its emitted dB is measured for 2 seconds to establish the reference dB level with the average dB value. An ultrasonic detector was developed to measure the dB using a contact ultrasonic sensor, displaying a graph of the measured dB and the average dB value. The bearing in good condition is then replaced with another bearing known to have a fault, such as lack of lubrication, oxidation, or dust contamination. The ultrasonic detector measures the dB generated by the faulty bearing, and the average dB is subtracted from the reference average dB to determine the level of change. Based on the level of change, the bearing defect is identified using the information in Table 1. The developed educational module enables the identification of bearing faults based on the increase in measured dB levels. In industry, early detection of bearing faults allows for planned corrective actions during non-productive periods.

Figure 4. Materials and methods implemented

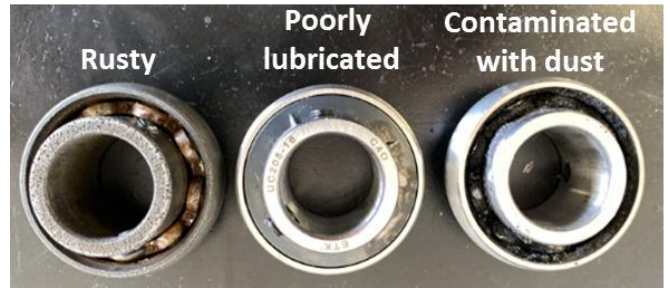
Figure 6. Bearings for inspection

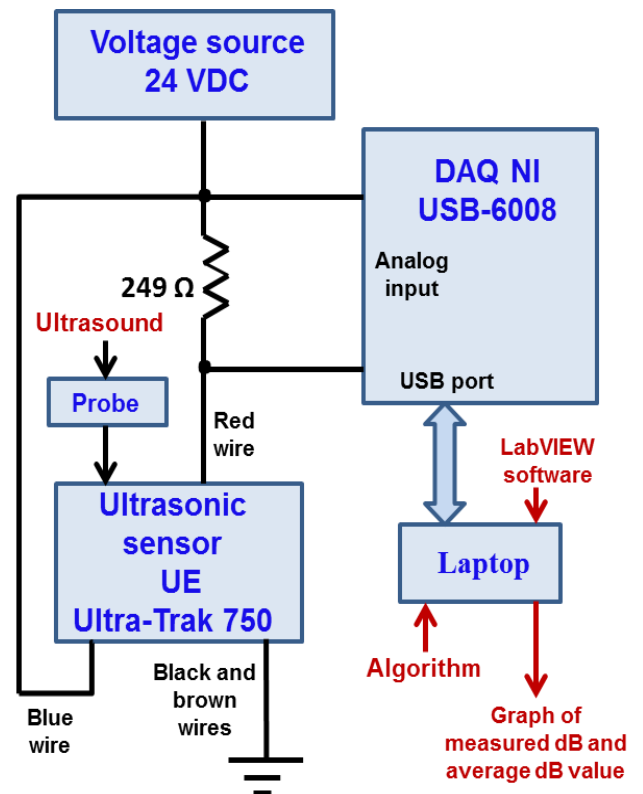
To measure the ultrasound dB in bearings and to identify the type of failure, an ultrasonic detector was developed. Figure 7 shows the block diagram of the developed ultrasonic detector. The UESYSTEM UE Ultra-Trak 750 contact ultrasonic sensor [12] is used to capture the ultrasound generated by the bearing under inspection, requiring a 24-volt direct current (VDC) power supply. A regulated 24 VDC source is developed from the 120 VAC line voltage. The 120 VAC is stepped down to 24 VAC using a transformer capable of supplying at least 100 milliamperes (mA). The 24 VAC is then converted to VDC using a 1 ampere (A) rectifier diode bridge and a 2200 microfarad (µF) capacitor. The output voltage of the rectifier bridge is 33.8 VDC, calculated using equation 1 [13].

Figure 7. Ultrasonic detector

The 33.8 VDC is converted to a regulated 24 VDC using the LM7824 regulator [14]. The 24 VDC is then filtered with an LC filter [13]. As shown in Figure 7, the Ultra-Trak 750 ultrasonic sensor has a series of color-coded wires for control. The black and brown wires are connected to the ground, while the blue wire is connected to 24 VDC to enable maximum sensitivity mode. The red wire is connected to 24 VDC through a 249 Ω current-limiting resistor. The voltage drops across the 249 Ω resistor generate an analog signal proportional to the dB of ultrasound detected by the sensor probe [12]. This signal is digitized at 10,000 samples/second and 12-bit resolution by the National Instruments' DAQ NI USB-6008 card [15]. The digitized data is then sent from the DAQ NI USB-6008 to a laptop via a USB port for processing.

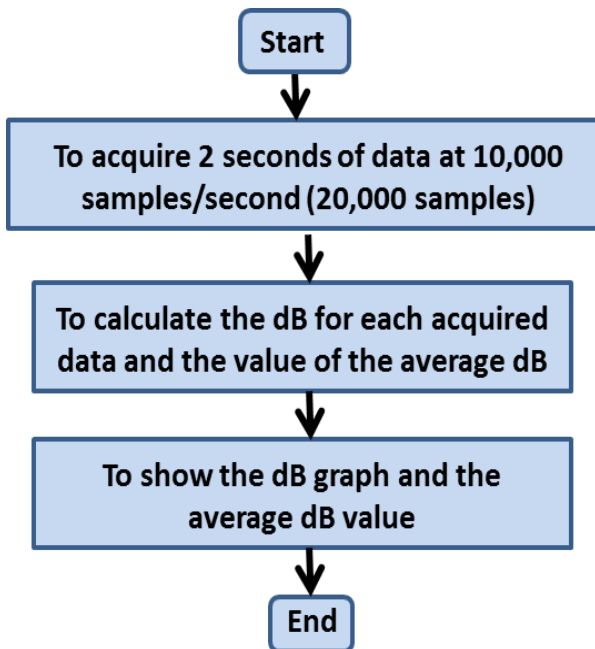
A graphical software, LabVIEW 2020, was utilized [16] to develop an algorithm responsible for data acquisition and processing, which displays a graph of the measured dB and average dB value as output. Figure 8 illustrates the flow chart of the developed algorithm, which configures the DAQ NI USB-6008 to acquire 20,000 samples at a sampling rate of 10,000 samples/second per measurement. The acquired 20,000 data points are stored in a data vector, as described in equation 2 [17].

Figure 8. Ultrasonic detector algorithm

As shown in Figure 8, the algorithm displays the graph of the measured dB for the 20,000 acquired samples and the average dB value as output. Figure 9 illustrates the results presented by the ultrasonic detector for each measurement taken. Figure 10 depicts the educational module inspecting a bearing.

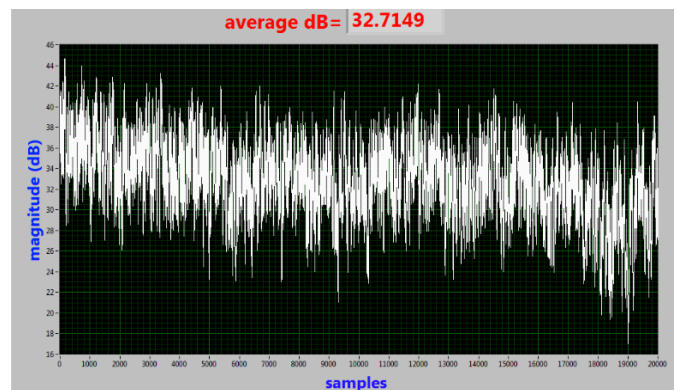
Figure 9. Ultrasonic detector results

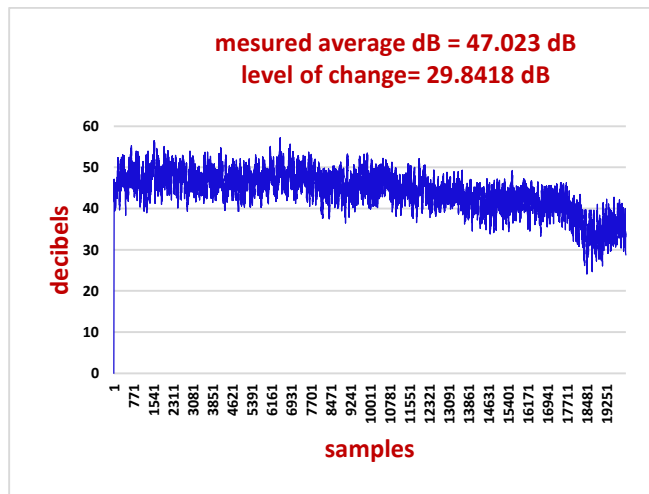
The bearing with the oxidation defect is installed in the educational module, and its emitted dB is measured for 2 seconds. Figure 15 displays the graph of the measured dB, the average dB value (47.023 dB), and the level of change concerning the established reference level (29.8418 dB). According to Table 1, a measured level of change between 16 dB and 35 dB indicates the beginning of failure, while a change between 35 dB and 50 dB indicates catastrophic failure. With a measured change of 29.8418 dB, the bearing is nearing to a catastrophic failure. In industrial settings, this information still allows for planned bearing replacement, enabling maintenance scheduling that minimizes downtime and optimizes productivity.

**Figure 15.** Decibels measured on rusty bearing
