## **River Bank Line Shift Caused by Brahmaputra in Morigaon District, Assam (1996-2021)**

### **Abstract**

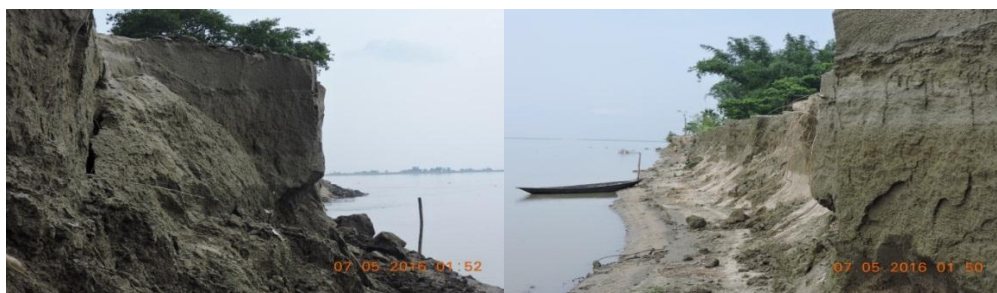
**Image: Bank erosion at Boralimari.**

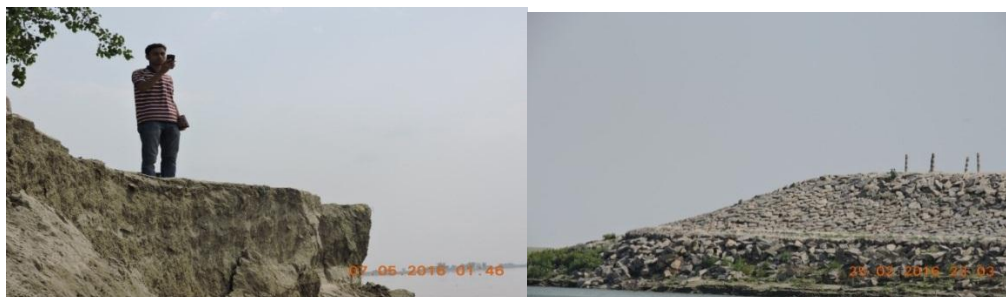
**Field survey with GPS points.Preventive Measure at Bhuragaon Revenue Circle.**

Numerous techniques and protection measures both structural and non-structural are taken for long-term protection by the government. These structural measures like hard material protection also and barrier across the river aims to protect the bank and redirects flow and energy of stream flow away from eroding bank. Agencies like the Water resource dept (WRD) of Assam, Brahmaputra and Flood and River Erosion Management Agency of Assam (FREMAA) funded by Asian Development Bank (ADB) that prioritizes to implemented riverbank protection. Pro-Siltation measures with RCC porcupines, sand-filled geo-bags, bank-slope pitching, embankment and protection work, etc are some of the methods that helped in checking river bank erosion at various locations in Assam. In Morigaon too, the WRD has taken measures to control erosion by setting up embankments of porcupine and on the bank of the river. Structural measures like concrete bank pitching have been carried out in various locations in Bhuragaon Revenue Circle and also non-structural measures like low-cost bamboo wall and banding and geotextile sandbags are used in Gagolmari and Kacharigaon to arrest the bank erosion on a temporary basis.
