Properties of Fiberglass Crossarm in Transmission Tower - A Review

Abstract

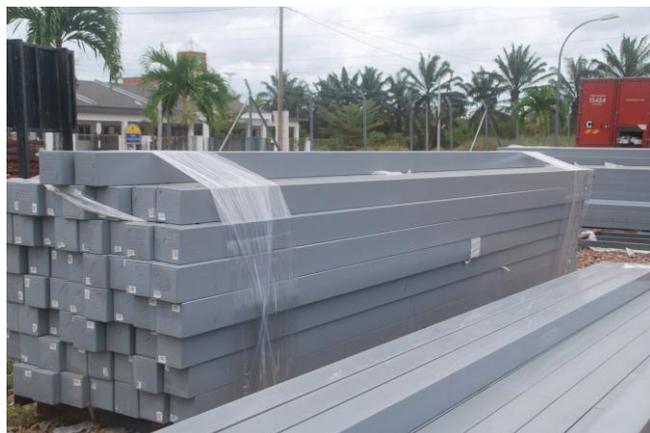
Figure 1: Example of Fiberglass crossarm

Alternative materials are needed for a better improvement of transmission line such as using fiberglass reinforced polymer. Fiberglass are more recent using in market and has lowest life cycle costs and longest expected lifespan up to 80 years compared to wood crossarm. Other than that, it can be easily installed and transported to difficult access area which can saving on installation costs. Besides, fiberglass crossarm is electrically non-conductive making live line energized work much safer. Overall conclusion, fiberglass crossarm has many benefits making it a good potential to utilize as transmission line structures [19].

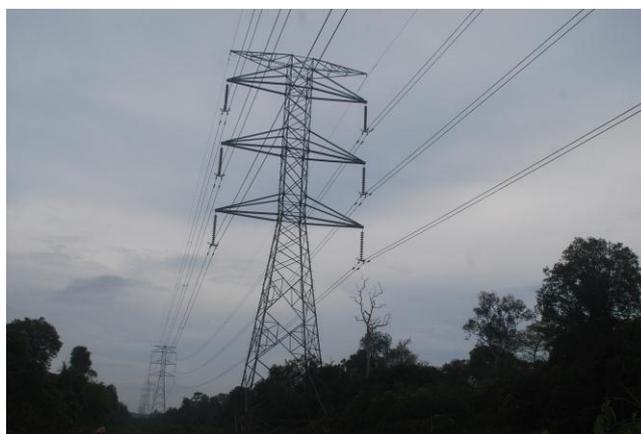
Figure 2: Example of Transmission Tower in Malaysia

TNB's Transmission Division generates three types of voltage for transmission line which is 132 kV, 275 kV and 500 kV transmission voltage acknowledged as the National Grid. The single largest transmission structure developed in Malaysia is 500 kV. It was also became the important transmission system in Peninsular Malaysia. Besides, the 275 kV is the huge transmission system while 132 kV is the medium transmission system in transmission tower.
