Rehabilitation Techniques to Address Frost Effects on Pile Foundations of Solar Power Generation Facilities in North America

Dr. Tahir Kibriya

*Senior Consulting Engineer, Black & Veatch, Toronto, Canada.
(ex Head of Civil Engineering / Faculty, NUST, Pakistan)*

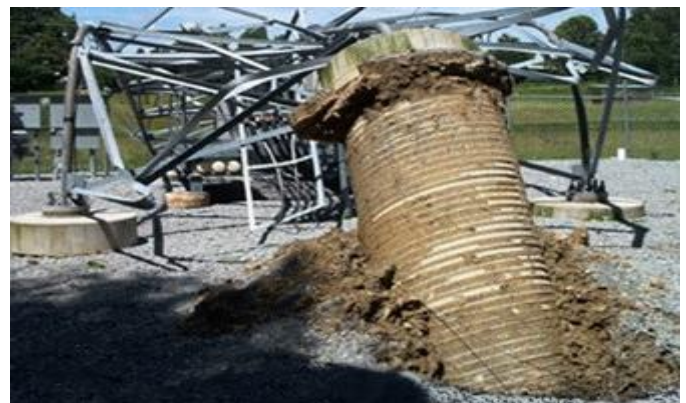
Figure 1: Frost uplift failing a tower foundation.

Effects of frost heaving can be devastating. Frost heaving has displaced wood piling upward as much as 14 inches in a single winter season on an Alaska railroad bridge near Fairbanks, Alaska. About 24 inches of frost heaving of piles has been recorded in a single year in Russia. About 8" of uplift has been recorded for a bridge piles at Norman Wells, Northwest Territory, Canada. The maximum recorded cumulative heaving of a pile in a Russian bridge is about 6½ feet. Piling of a bridge 8 miles southeast of Big Delta, Alaska, has been frost heaved by 11 feet. Frost heaving combined with wind uplift can overturn communication towers as shown in Figure 1 below.

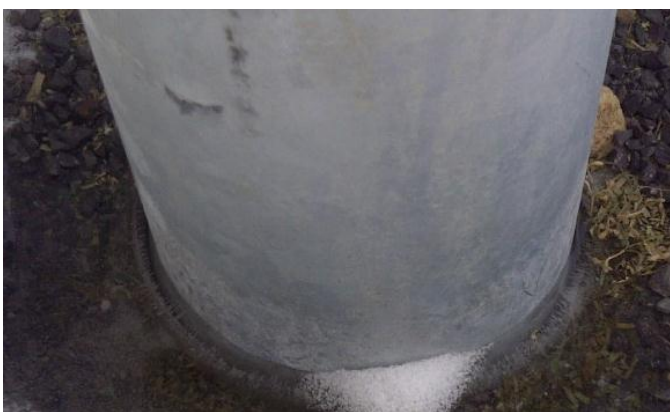
Figure 2. The uplift movement of the pile foundation can be seen at the base of the pile.

In case some piles are visually observed to have heaved, a complete survey of the area is usually carried out to establish the extent of damage and the precise amount of heave which has occurred. Figure 2 below indicates a pile which has been affected by frost. It is quite rare that complete rows of piles experience uniform heave, though such heave will not create much of issues for the facility. Usually a number of piles in each row will experience pile heave while others will not be affected. The piles experiencing heave are usually observed to experience different values of uplift which are rarely uniform as can be seen in Figure 3. The generally acceptable limits of pile heaving are 36mm of differential heaving based on IEC 61646 (Thin-film terrestrial photovoltaic (PV) Modules – “Design qualification and type approval”) since beyond these limits, excess torsional stresses are induced in the solar panels along with additional flexural stresses induced in the racking beams possibly causing structural damage in addition to the connecting wires and connections getting into failure/breakage due to induced tension.

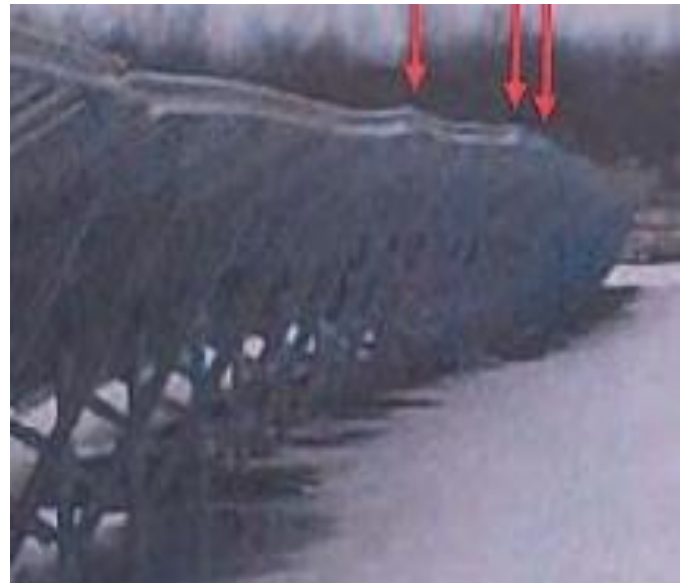
Figure 3. Piles affected by frost showing deformation of the racking with red arrows.

facilities stop producing current or following an extreme event and at the end of every winter season. During such inspections, piles, combiner boxes and their wiring, solar panel racking and the joints where wires connect are closely inspected. Moving out of piles can be felt at the pile-grade interface, damage of combiner boxes at pile-box connections and wires at sockets getting into tension/ breaking, wire connections getting taut/ broken at the junction of racking/ panel connection, bending of racking beams along the longitudinal axis due to differential uplift of the piles.
