Using Vibration Analysis to Identify & Correct an Induced Draft Fan's Foundation Problem of a Pollution Control Device - A Case Study

Abstract

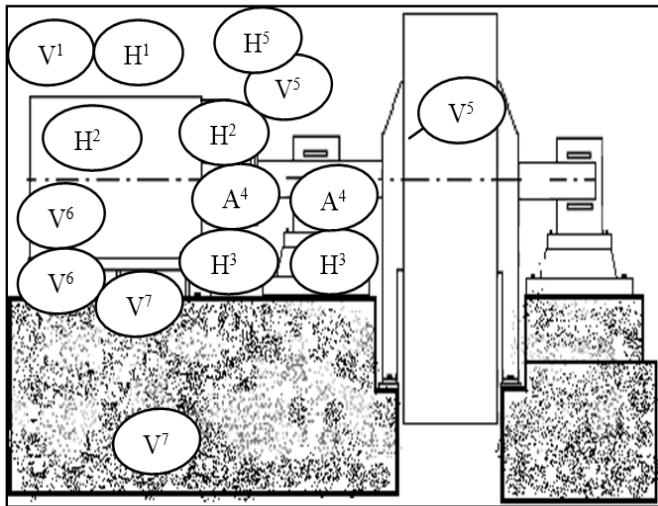
Figure 4. Phase analysis axis & location are being shown

1. Motor NDE horizontal to vertical :12⁰
2. Motor NDE horizontal to Motor DE horizontal :1⁰
3. Motor DE horizontal to Fan DE horizontal :14⁰
4. Motor DE axial to Fan DE axial:17⁰
5. Fan DE horizontal to vertical :110⁰
6. Motor base vertical to base frame vertical:1⁰
7. Motor base vertical to foundation vertical :4⁰

From the above result we find the phase shift (delta) value is 0⁰ or 180⁰ (approximately) vibration analysis concludes weak base rigidity/mechanical looseness at structure and unbalance and to confirm the same the next first step was to do the bump test to check for resonance..

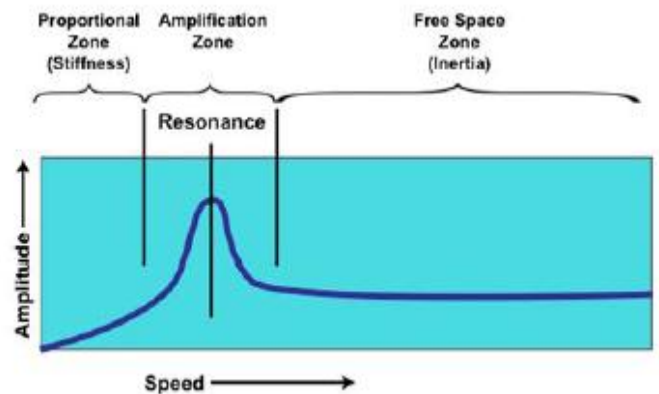
Figure 7. Bode Plot Amplitude versus Speed

From the above plot it is observed that as the operating speed is increased beyond the resonant frequency the vibration amplitude will decrease somewhat but in this case study it was not possible to vary the motor speed so a next alternative had to be implemented.

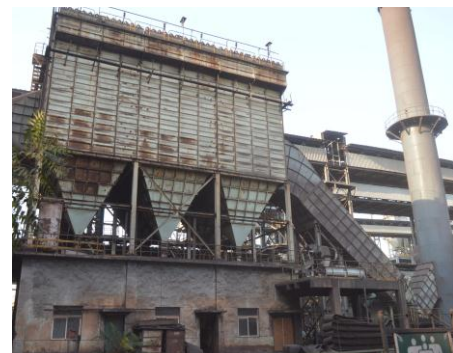
Figure 12. Picture of the 12 Chamber Filter Bag Unit

The reason of fast wearing out was due to abrasion of sand materials which were leaking from the partially damaged filter bags of the pollution control device. In the pollution control device there are 12 chambers and each chamber has 192 bags and to locate and replace the damaged from the total 2304 total bags is a time consuming task which needs a long shut down which the operation cannot afford because of production schedule.

With even best maintenance practices filter bags getting damage is a routine aspect and most of the time operation need to be continued with partial damaged filter bags till a major shut down is available to replace the bags. In this case study the filter unit has 2304 bags distributed in 12 chambers. (Fig:12)
