Identifying the alignment of the Piston Ring in Turbocharger Assembly Line Process

S. Jerin Winne and B. Mohanraj

Key words - Turbocharger piston ring – Alignment Testing and Error Proofing

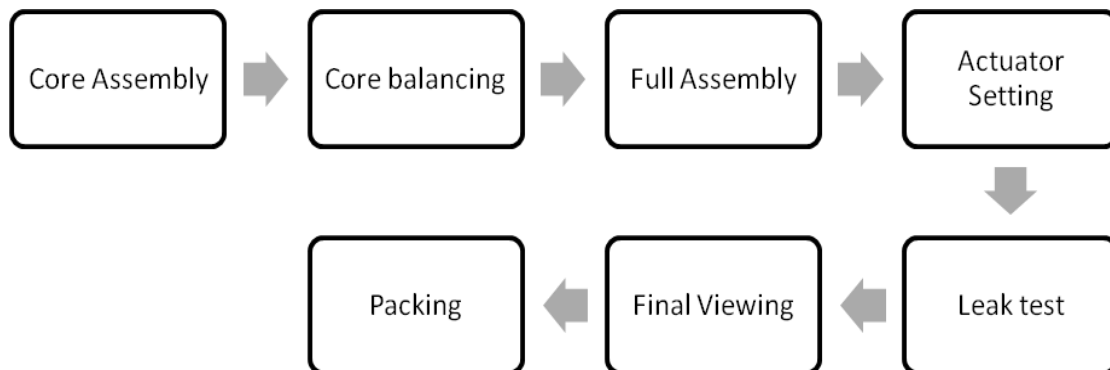
Fig.1 Turbocharger Assembly process

Presently there are 12 processes in this product line assembly [7]. The Line is operated by operators at stations performing single operation. The fixtures are mounted in the assembly stations and the corresponding tools and the turbo charger are loaded in the flow test rig. The step by step assembly process are Housing Sub Assembly, Alpha Setting, Greasing Operation, Actuator Assembly, Turbine Housing Beta Assembly[1], Turbine Housing Beta Tightening, Actuator Setting flow test testing, Tube Clamp Crimping, Final Inspection[10], Protective Plugs Assembly Operation and Packing Operation, the assembly process as shown in Fig.1
