## **Intangible Bank Erosion: A Threat to the Life of Matla-Bidyadhari Interfluve in Sundarbans**

### **Abstract**

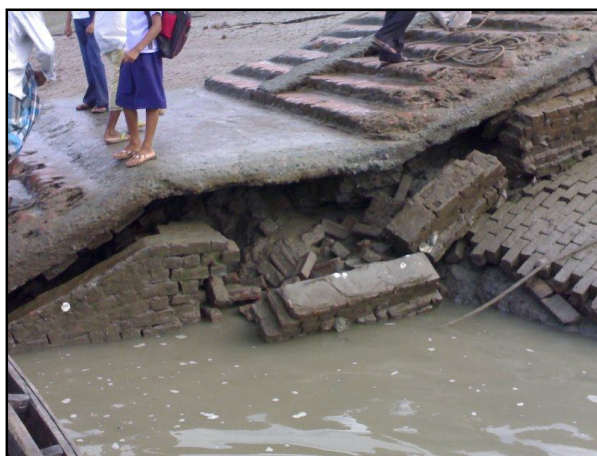
**Plate 1:** Erosion due to undercurrents at the ferry ghat near Basanti Bazaar, 2008

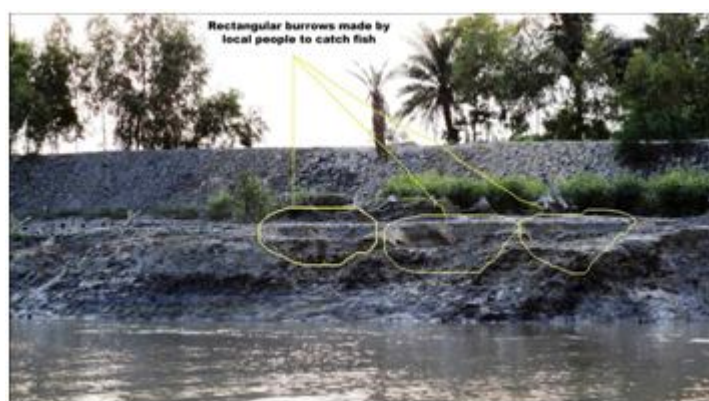
**Plate 2:** 'Choukos' (Rectangular burrows made temporarily to catch shrimps or prawns during high tides along the river banks), 2011

Besides this another though minor anthropogenic factor accelerates the undercutting process of the river banks of Sundarbans is, the continuous walking along the banks by the local 'Dhibars' or 'Jeles' (nomadic fishermen or fisherwomen in Bengal) and making of 'choukos'(Plate 2) which led the basement of the bank along the tidal channels very rough and

full of holes. The very newly deposited silt and clay by the tidal channels along the toe of the immature banks are when are undisturbed remains smooth and tidal water use to flow up and down without scouring the surface of the toe of the banks. But it is noticed that whenever lots of holes are created by the 'Mindharas' (local term used for fisherman) who mainly comes down the bank at the river to catch the 'Bagda' (Prawn) their walking on the bed of the river just adjacent to the banks toe creates lots of holes or bores on the juvenile silt. Thus the pressure of their feet creates the holes which are enlarged and slowly increase in depth and area by the small whirling of water or eddies created during the high tides. Though it seems a very negligible cause behind the weakening of the structure of the basement of the tidal banks, but
